SB-10045285-1455

SI B51 25 12
Body Equipment

ActiveE: Interior Water Ingress

E82E

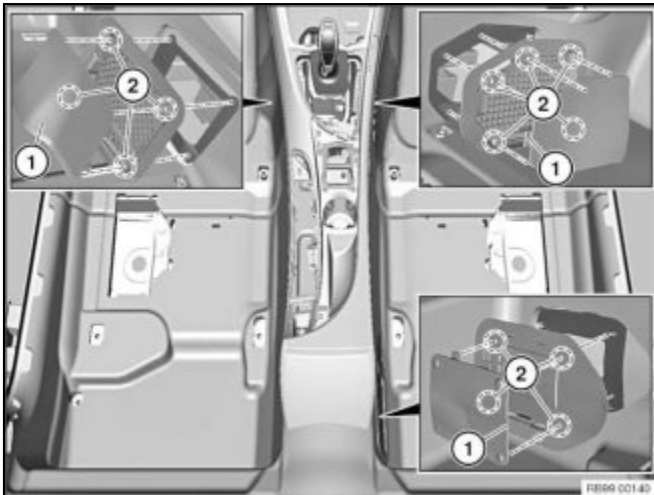
The customer complains about wet carpet in the center tunnel area. Water may penetrate into the passenger compartment when the vehicle is driven through deep puddles.

Insufficient sealing of the service openings in the transmission tunnel.

1. After verifying the complaint, unclip the tunnel trim (1) at the marked points using a suitable tool, and remove the covers (1).
2. Release the screws (2) and remove the tunnel frame.
