SB-10045301-1882

SI M17 04 12
Cooling SystemsJuly 2012
Technical Service

SUBJECT**Service Action: Retrofit of the Engine Coolant Temperature Sensor****MODEL**

R60 with manual transmission (N16 or N18 engine)

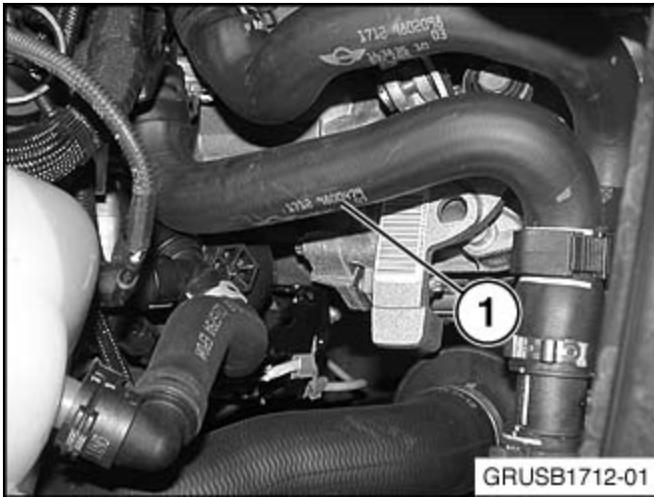
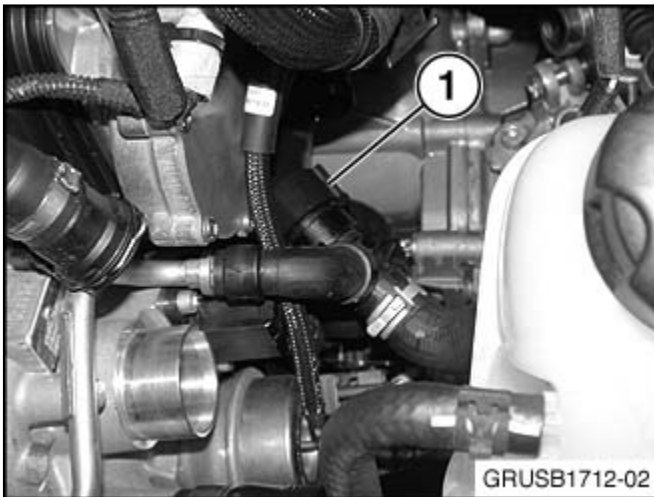
Remove the coolant hose (1). This hose will not be reused.

Remove the fresh air intake tube and the intake tube from the air box to the turbo to gain access to the coolant hose.
