**SB-10045302-4037**

SI M17 05 12  
Cooling SystemsJuly 2012  
Technical Service

**SUBJECT****Service Action: Retrofit of the Engine Coolant Temperature Sensor****MODEL**

R60 with automatic transmission (N16 or N18 engine)

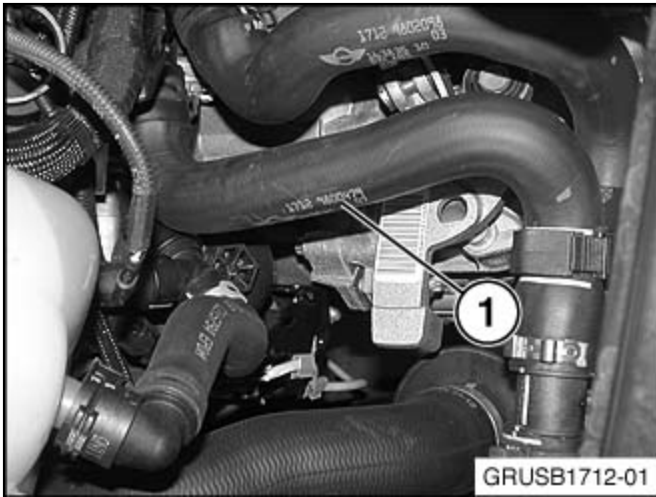
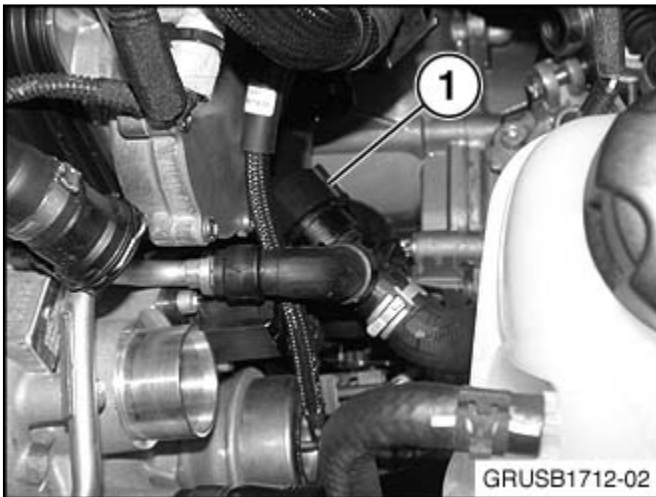
Remove the coolant hose (1). This hose will not be reused.

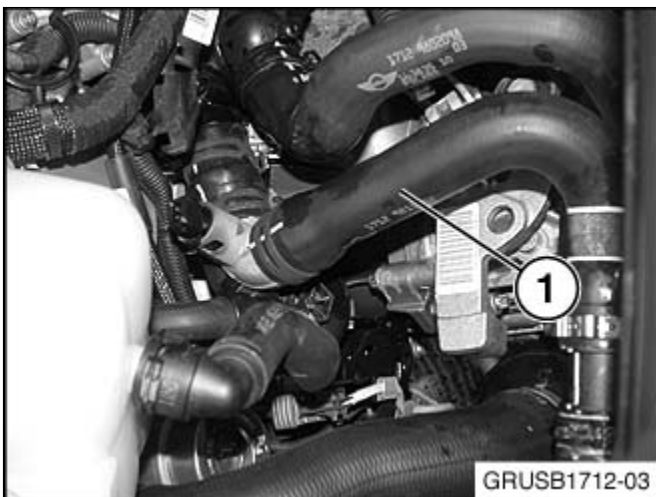
N18 engine only! Install spacer P/N 64 53 7 578 707 (1) on the coolant line as shown.

Note: The spacer needs to stay in this position when installing the new coolant hose P/N 17 12 9 811 351 (next step).

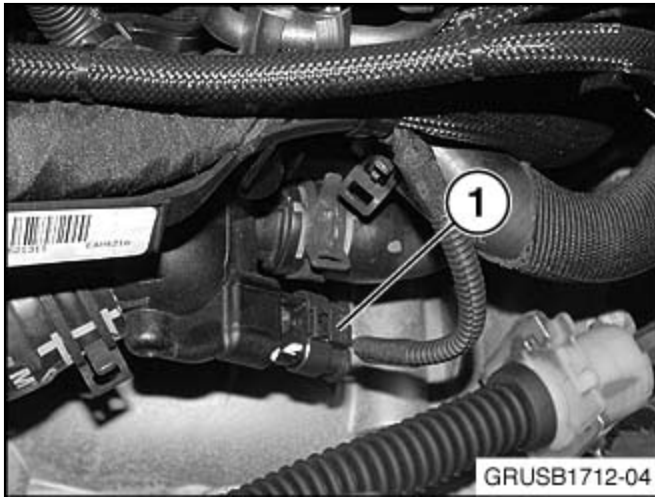
Install the new coolant hose with sensor P/N 17 12 9 811 351 (1).

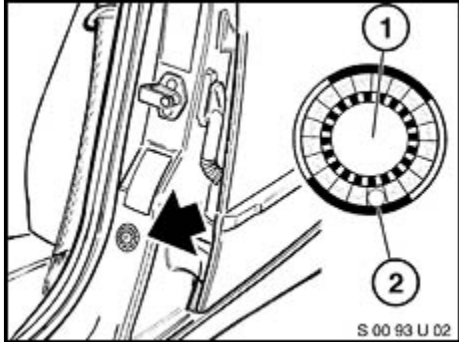
This Service Action has been assigned code number **53**. After the vehicle has been checked and/or corrected, obtain a label (MD20-040) and:

- A. Emboss your MINI dealer warranty number in the middle of the label (1);
- B. Punch out code number **53** (2), printed on the label; and
- C. Affix the label to the B-pillar as shown.
