Service Bulletin

Bulletin No.: PIP5049

Subject: Difficult To Get Into Or Out Of Gear Excessive Free Play In The Shifter

Models: 2011 - 2013 Chevrolet Cruze
2012 - 2013 Chevrolet Sonic
Equipped with 6 speed manual transmission RPO MF3 MR5 MZ0 MZ4

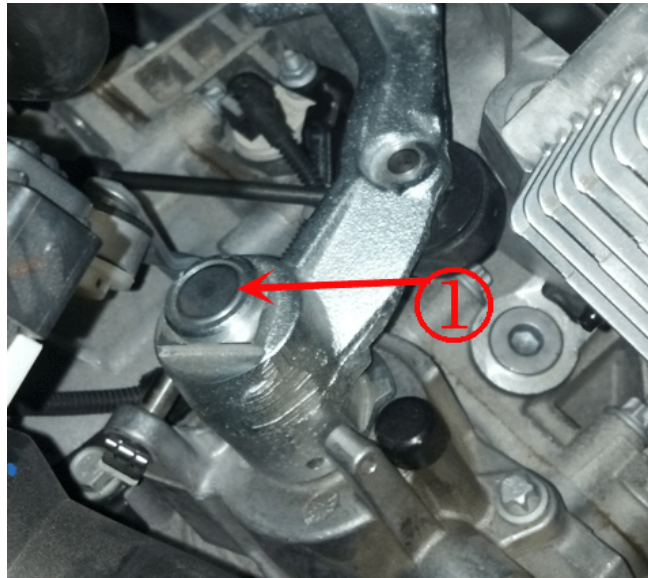
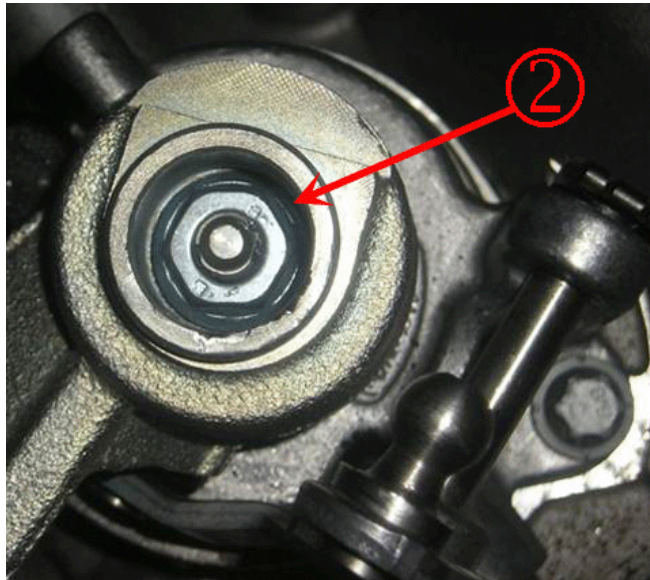
2892314

This condition can be caused by a nut that has come loose on the shift tower (see Item 2 located under plug item 1). To verify this condition from inside the car, shift the transmission into any gear with the engine off. Then check the shift tower for play. The shift tower should not move loosely when the transmission is in gear. Any excessive movement that can be felt at the shift tower could be the result of a loose nut. At this time the shift tower is not serviceable and this condition would require transmission replacement.
