SERVICE PROCEDURE

G-12520
July 2012

SUBJECT: NON-COMPLIANCE RECALL
Roof-mounted emergency exit on certain CE and RE bus models built 01 April 2011 through 31 March 2012 with ProLo roof-mounted emergency exits produced by Specialty Manufacturing Inc. (SMI).

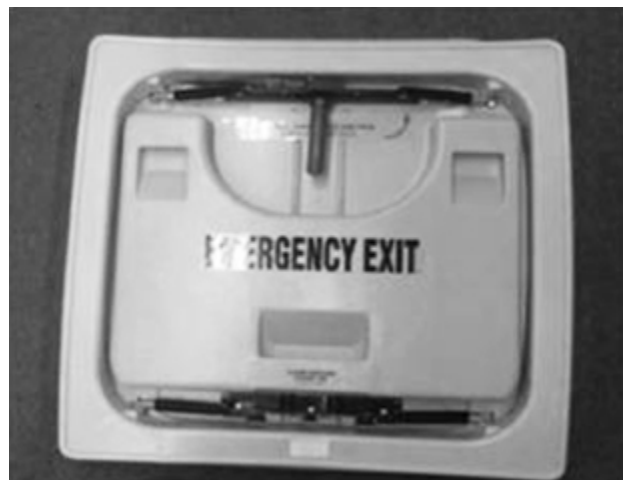
Figure 1

1. Park vehicle on flat surface, shift transmission to park or neutral, set parking brake, and block wheels to prevent vehicle from moving in either direction.
2. Inspect label just to right of handle on latch lid for build date to determine if hatch was manufactured from 01 April 2011 through 25 March 2012 (Figure 1 and Figure 2).

3. If hatch was manufactured between dates listed in step 2, proceed to step 4 and replace hatch rear support receiver. Otherwise, proceed to step 5.
4. Please refer to SMI repair instructions included with this letter for each roof-mounted exit on the bus.
5. Remove wheel blocks.
