T-SB-0101-12

# Truck Bed Floor Rust / Corrosion

## Applicability

| YEAR(S) | MODEL(S) | ADDITIONAL INFORMATION |
|---|---|---|
| 2007 – 2011 | Tundra | |

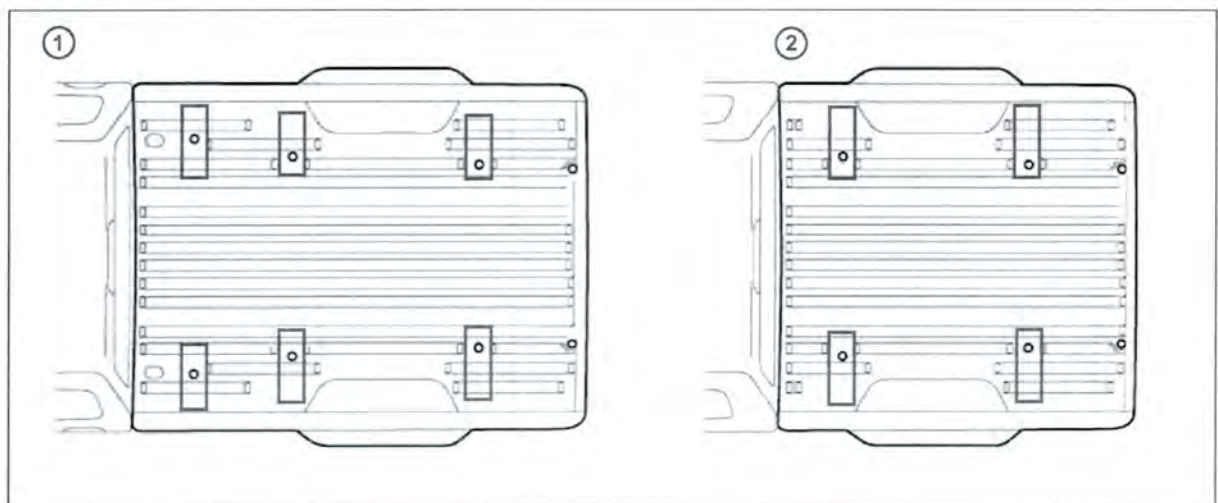
1. Inspect the bed floor surface in the specified areas shown in Figure 1.
  - A. If the paint is bubbling or rust/corrosion is present on the topside (as viewed from above) of these specified areas of the floor surface then perforation of the underlying sheet metal has occurred.
  - B. If bubbling or rust/corrosion is not present in the specified areas identified in Figure 1 STOP. This bulletin does NOT apply.

| 1 | 6.5 ft and 8.1 ft Bed Assemblies | 2 | 5.5 ft Bed Assembly |
