Technical Service Bulletin

42 Rear axle shaft leaks at differential - S4 and S5 with Quattro Sports rear differential (PR – PDU, PDR, or GH2)

42 12 11 2026049/4 July 5, 2012. Supersedes Technical Service Bulletin Group 42 number 11 – 09 dated October 25, 2011 for reasons listed below.

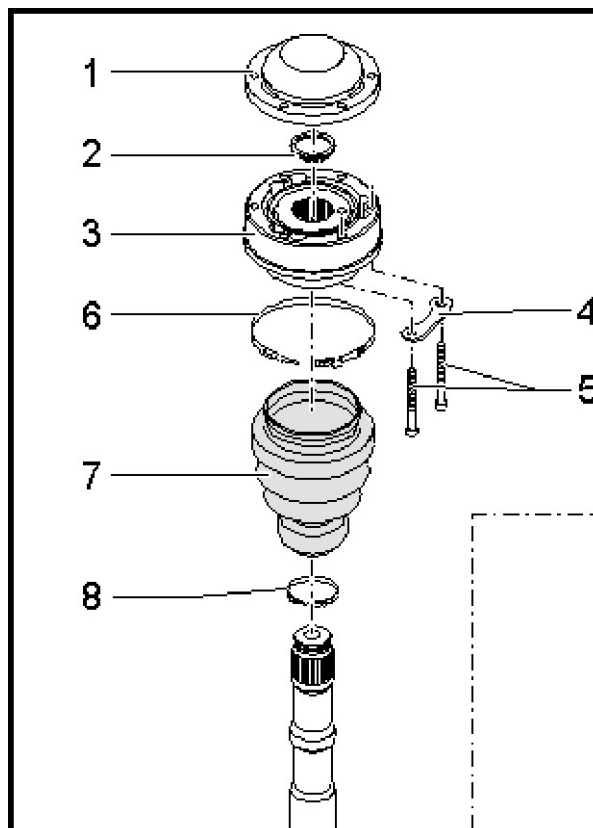
Oil leak in the area of the Quattro sports rear differential (PR-PDU, PDR, or GH2) side flange, or axle shaft inboard flange.

Insufficient sealant on the protective cap on the inboard constant velocity joint at the rear differential on vehicles with a sports differential.
The oil is from the constant velocity joint grease. This is a normal characteristic and does not affect the function of the driveshaft.

Figure 1. Structure of drive shaft on differential side.
(1= protective cap) (3 = inner constant velocity joint)

1. Inspect the rear inner CV joints where they connect to the read sports differential:
Oil sweating or residue – do not make any repairs.
Clear oil drips – proceed to step 2.

2. Check the source of the fluid:
Grease used in the drive shaft CV joints is almost odorless. If the fluid does not have any odor, proceed to step 3.
Differential fluid has a pungent smell. If the fluid has a pungent smell, this TSB does not apply.

3. Per instructions in *ELSA Web >>> Chassis >>> Suspension, Wheel, Steering >>> Rear Suspension >>> Disassembly and Assembly >>> Inner CV Joint*, use great care removing the protective cap.
If the cap is undamaged after removal, it can be reused.
If the protective cap is damaged during removal, a new cap must be installed.

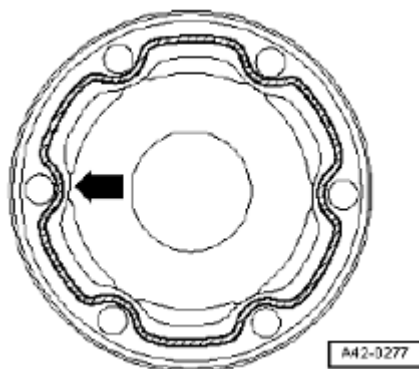
Figure 2.Protective cap with sealer.

4. Be sure the sealing surfaces are clean and dry.
Apply the sealer (Part Number **D 454300A2**) with a diameter of **4 - 5 mm** on the protective cap.
