# Technical Service Bulletin

## 94F6 UPDATE – Tail Lamp Seal (NVLW)

94 12 73 2029196/1 April 16, 2012.

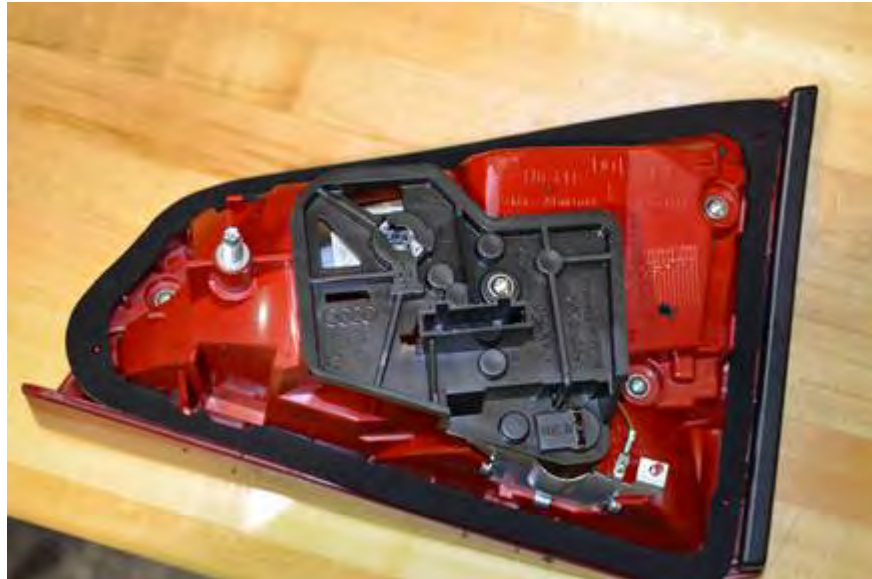
*Figure 1. Tail light.*

The contacts of the inner LED tail lights may develop oxidation which may cause malfunctions of the inner LED tail light. The outer tail lights are not affected and still function properly.

On Audi A4 vehicles with LED tail lights manufactured within a specific period, it is possible that oxidation can occur on the contacts of the inner LED tail lights due to environmental factors. This can lead to malfunctions. The outer tail lights are not affected and still function properly.

1. Replace seals for inner tail light assemblies (left and right sides).

**Tip:** To remove the old seals, warm gently with a hot air blower. Use the lowest setting, as excessive heat causes the tail light assemblies to deform.
