# Technical Service Bulletin

## 94 Headlight Warning on in Cluster (Xenon Plus With or Without Adaptive Light)

94 12 74 2029194/1 April 19, 2012.

Model(s)	Year	VIN Range	Vehicle-Specific Equipment
Audi Q7	2010 – 2012	000001 – 999999	Premium Plus or Prestige Option Packages

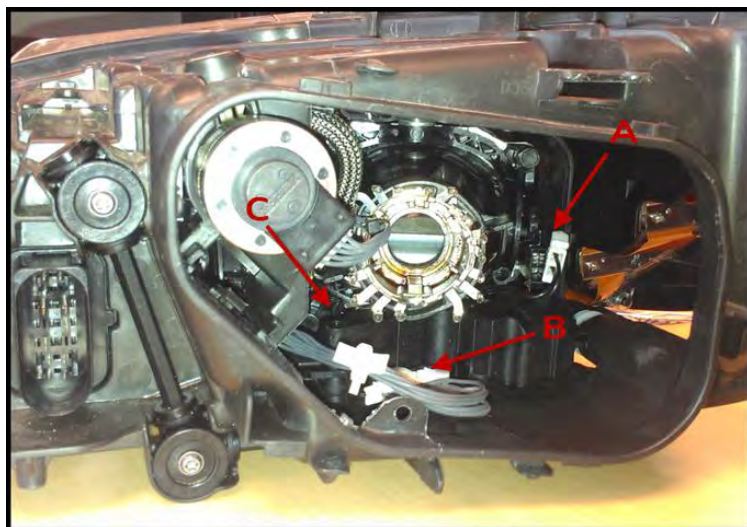
One or more of the connectors inside the headlamp housing are disconnected fully or partially from the factory.

**Figure 1.** Back of Tri-Xenon Headlight showing three connectors (Bi-Xenon) will only have a single “A” connector.

2. Remove the covers from the back of the headlamp housing.
3. Physically check all the connectors inside the headlamp housing for proper seating and visually inspect the locks to ensure they are fully engaged.

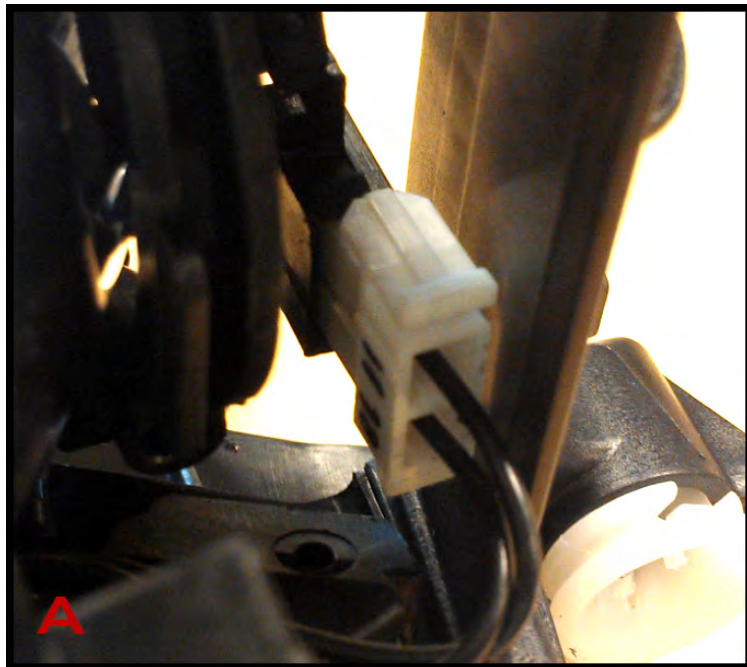
Connector "A" (Figure 2, A) can be seated but not fully engaged. When pushing on this connector the projector will swivel, thus you will need to hold the projector housing when applying pressure to the connector.

*Figure 2. Connector "A" shown not fully seated.*

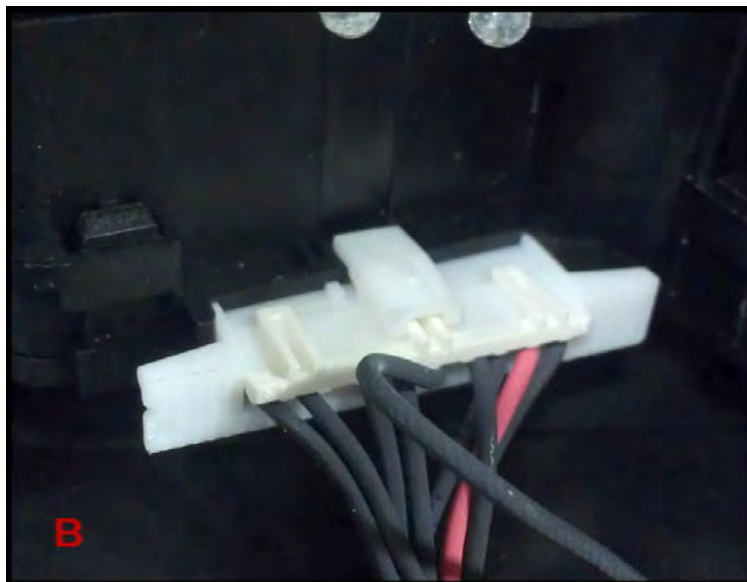
Connector "B" (Figure 3, B) can be fully locked into place but it can be rotated 5-10 degrees off center. Thus, please check to ensure the harness connector is seated parallel to the connector housing on the headlamp.

*Figure 3. Connector "B" shown off center.*

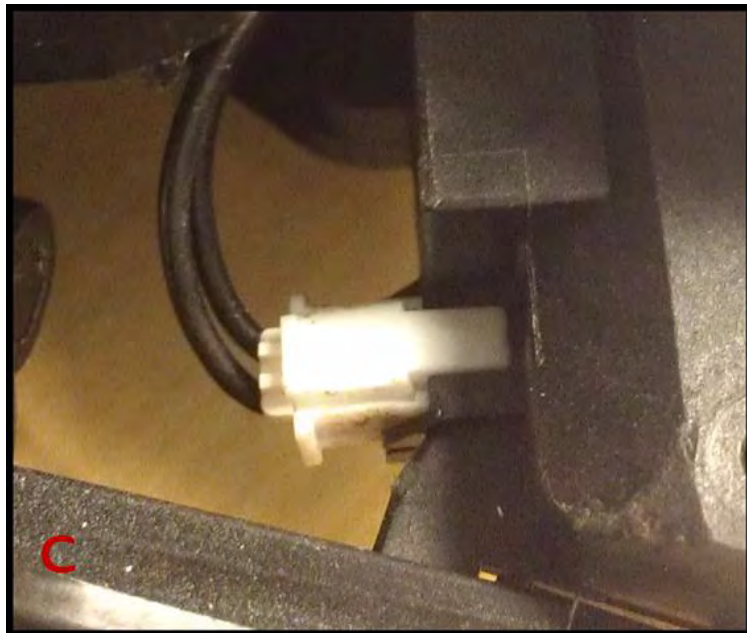
Connector "C" (Figure 4, C) is located behind the motor mechanism, which rests below the projector lens. This is a very small two-pin connector. Take care when wiggling this connector because if it becomes fully disconnected, it is very difficult and almost impossible to reconnect without using special tools. Place your finger, or a set of small bent pliers, on this connector and pull towards yourself to fully seat the connector.

**Figure 4.** Connector "C" shown in the locked position.
