Technical Service Bulletin

94F6 UPDATE – Tail Lamp Seal (NVLW)

94 12 75 2029196/2 April 24, 2012. Supersedes Technical Service Bulletin Group 94 number 12 – 73 dated April 16, 2012 for reasons listed below.

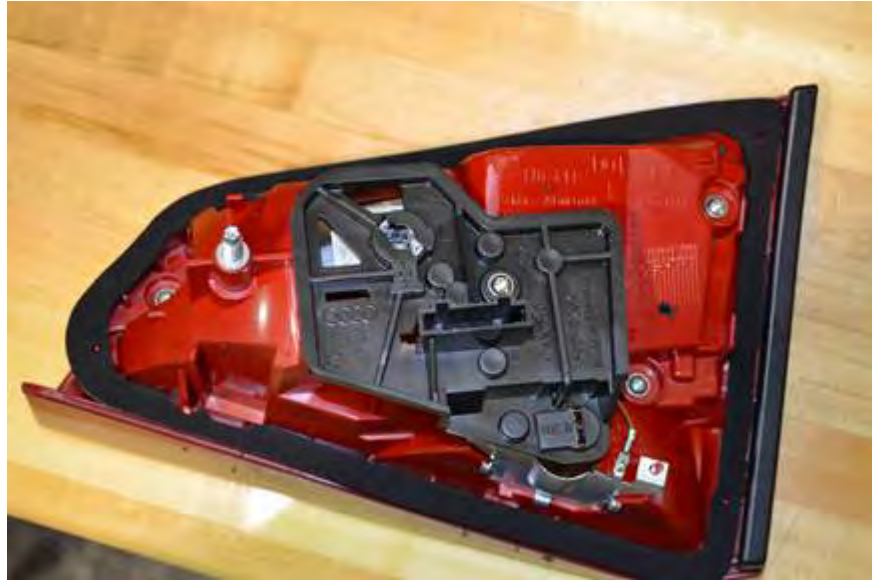
Figure 1. Tail light.

The contacts of the inner LED tail lights may develop oxidation which may cause malfunctions of the inner LED tail light. The outer tail lights are not affected and still function properly.

On Audi A4 vehicles with LED tail lights manufactured within a specific period, it is possible that oxidation can occur on the contacts of the inner LED tail lights due to environmental factors. This can lead to malfunctions. The outer tail lights are not affected and still function properly.

1. Replace seals for inner tail light assemblies (left and right sides).

Tip: To remove the old seals, warm gently with a hot air blower. Use the lowest setting, as excessive heat causes the tail light assemblies to deform.
