Technical Service Bulletin

94 Adaptive light: Headlight range control warning displayed in instrument cluster - DTC 00003 Control Unit Faulty

94 12 83 2024877/4 July 9, 2012. Supersedes Technical Service Bulletin Group 94 number 12 – 82 dated June 26, 2012 for reasons listed below.

Model(s)	Year	VIN Range	Vehicle-Specific Equipment
A8	2008 – 2010	Not Applicable	Adaptive light
A6	2008 – 2011		
Audi Q7	2008 – 2013

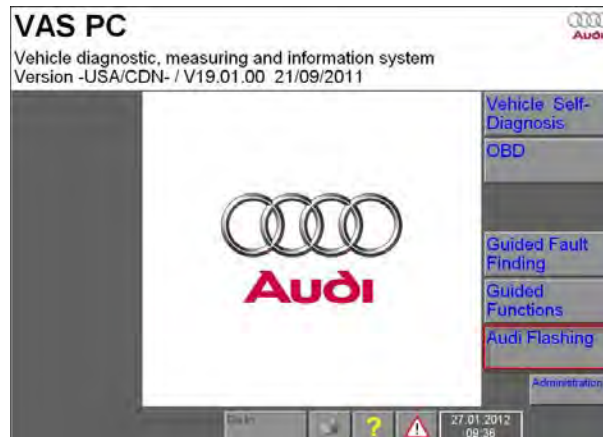
Figure 2. Audi Flashing.

- Turn off any appliances with high electromagnetic radiation (such as mobile phones).
 - If communication with a module cannot be properly established, appropriate repairs must be made before attempting SVM. If the tester cannot communicate with a module, the tester cannot flash software onto the module.
5. Enter the SVM code into the User Test Plan by selecting the **Audi Flashing** option at the main tester screen, unless otherwise directed by the TSB or TAC Helpline.
