## ***C1 Action***

Date: July 2012  
Action No.: C1A – 12 07 01  
Group: 91

SUBJECT: **Model 166**  
**Model Year 2013**  
**Check Torque of Front Seat Bolts**

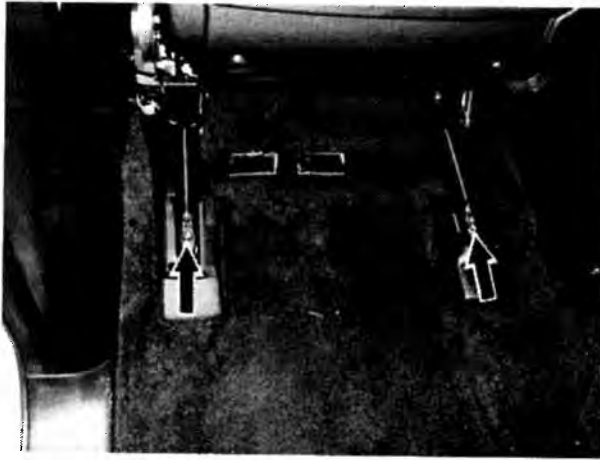
Figure 1

This Customer 1 Action has been initiated because DAG has determined the bolts (3/seat) on the front left and front right seats may not be torqued to specification. Dealers will immediately check the torque of the bolts indicated in the below work procedure and submit a warranty claim for the repair.

1. Move left front seat forward to end position.
2. Torque 2 bolts (arrows, Figure 1) on rear of front seat (securing seat to body) to: 50 Nm + - 5 Nm.
3. Carefully unclip cover (arrow, Figure 2) on side of front seat and remove cover (arrow).
