SB-10045581-2748

Service Campaign 62-01

AFFECTED: Certain 2013 Winnebago Adventurer, Journey, Tour and Itasca Suncruiser, Meridian and Ellipse model motor homes.

SUBJECT: Roof A/C Mounting Verification

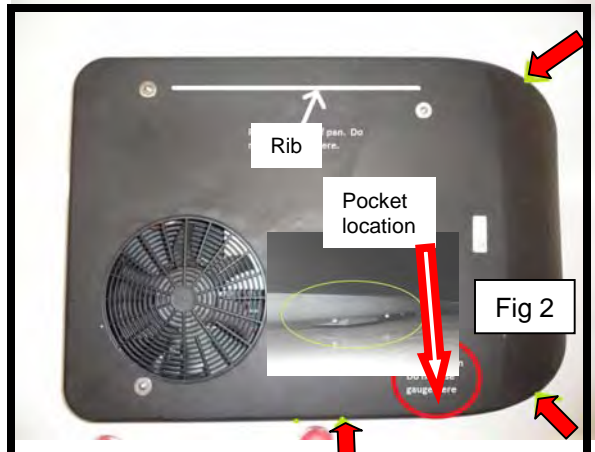
2. Use gauge (fig 1) at front right, front left corners and the middle of the right side areas indicated by arrows (fig 2).

Note: Make sure gauge does not interfere with rib on bottom of pan on left side or pocket on right side. Also pocket should not contact roof (fig 3).

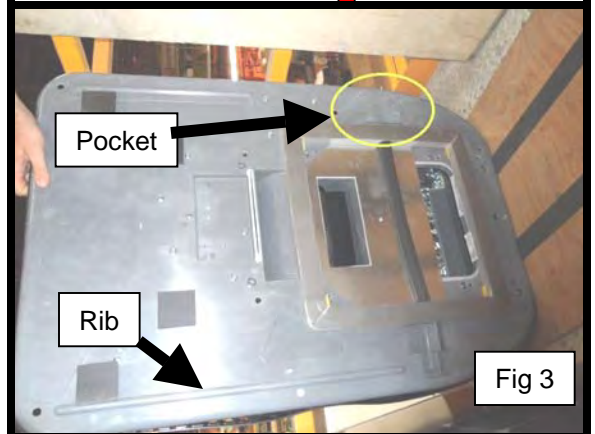
The 7/16" gauge should slide under the pan in all three test points and the 3/4" gauge should not.

If gap test passes no further action required.

If gap test fails, refer to **Roof AC Mounting Repair Process**.
