SERVICE CAMPAIGN BULLETIN

NTB12-048

VOLUNTARY SERVICE CAMPAIGN 2010 – 2012 REAR AXLE CLICK

APPLIED VEHICLES: 2010 – 2012 Armada (TA60)

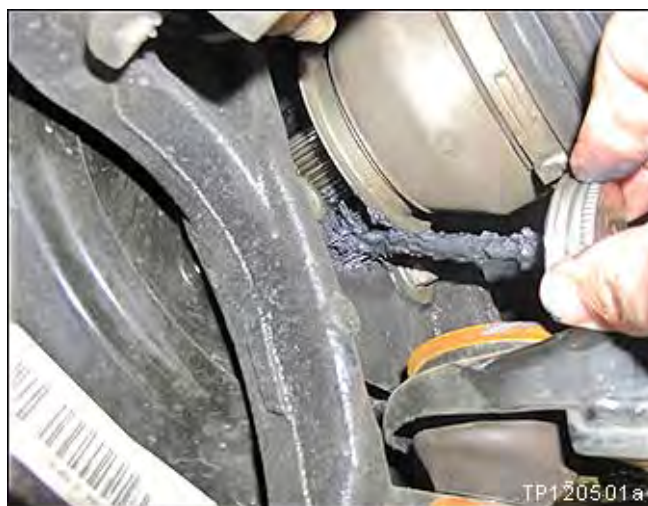
Figure 5

Some potentially affected 2010-2012 Armada vehicles may experience a clicking noise in the rear axle area due to incorrect grease application. This is not a safety issue, and the vehicle still meets and/or exceeds all applicable safety standards.

8. Apply a minimum of 1.0g of Molykote M77 Grease in an even coating to the bearing surface where it contacts the rear axle (see Figures 5 and 6).

- Use **only** Molykote M77 grease (P/N 44003-7S000). **Do not use any other grease.**
