TECHNICAL BULLETIN

UPS0512-4bNAS1

05 APR 2012

SECTION: 417**Update Prior to Sale: Right-Hand Rear Fog Lamp****AFFECTED VEHICLE RANGE:****XK (X150)****VIN: Specific vehicles; see attached list
Model Year: 2012****CONDITION SUMMARY:**

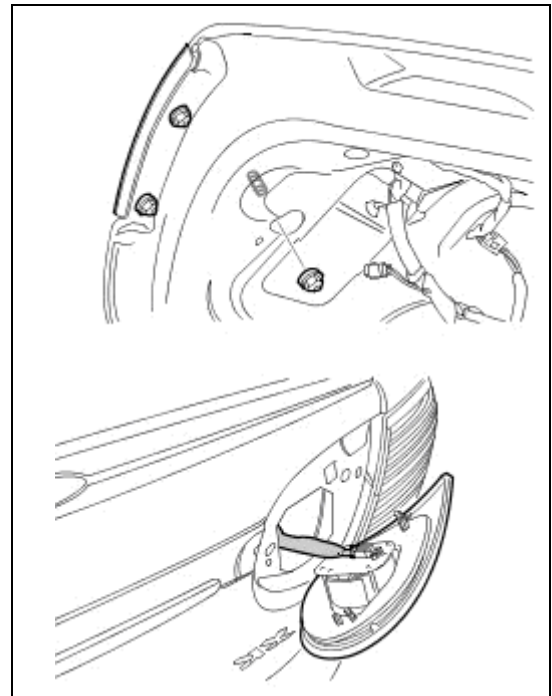
Situation: A limited number of 2012 model year Jaguar XK vehicles may have been manufactured away from process and in some cases the right-hand (RH) rear fog lamp may be incorrectly welded.

1. Convertible only: refer to Workshop Manual section 501-05: *Interior Trim and Ornamentation*, and remove the luggage compartment lid trim panel.
2. Coupe only: refer to Workshop Manual, section 501-05: *Interior Trim and Ornamentation*, and remove the liftgate lower trim panel.
3. Remove the right-hand (RH) reverse / fog lamp:
 - Remove the three (3) plastic nuts.
 - Disconnect the electrical connector.
