**SB-10045719-5139**

BULLETIN NUMBER:  
CB12-J-001B

## **VOLUNTARY EMISSION RECALL TURBOCHARGER LOOSE HOUSING – #V1202**

- 2007-2010MY Isuzu N-Series
  - 2007-2010MY GMC/Chevrolet W-Series
- Equipped with Diesel Particulate Filter (DPF)

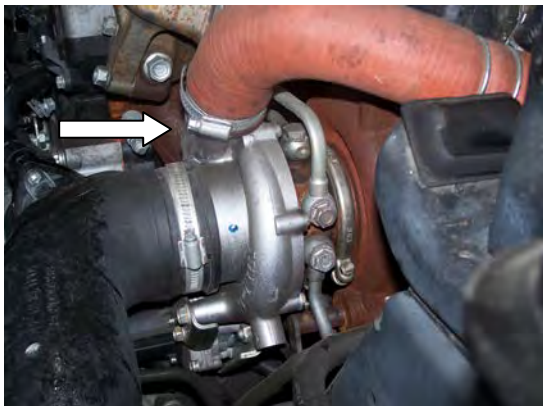
Figure 1 – Location of Serial Number Plate

## INSPECTION PROCEDURE

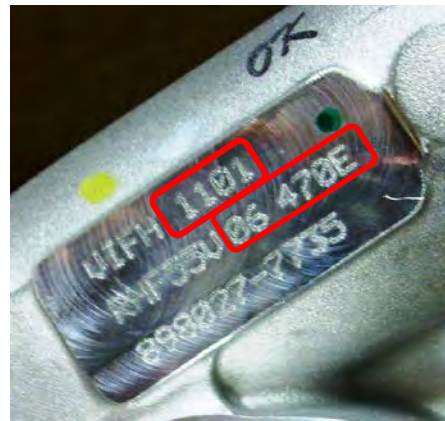
Figure 2 – Serial Number – 110106470E

1. Top Row: Year, Month (ex: 2011, January)
2. Middle Row: Day, Sequence (6<sup>th</sup> day, #470 built on that day)

4. Is the serial number within the production range of this emissions recall? Refer to the Turbocharger Serial Number Production Range provided below.

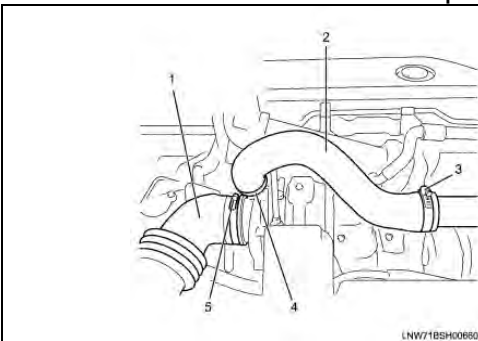
Figure 7

1. Air Intake Duct
2. Charge Air Hose
3. Clamp
4. Clamp
5. Clamp

7. Disconnect the connector from the turbocharger actuator.
8. Disconnect the air intake duct from the turbocharger (see Figure 7).  
**NOTICE: Do not remove the tamper proof bolts that clamp the PCV hose from the intake duct.**
9. Remove the charge air hose from the turbocharger and the charge air cooler (see Figure 7).
10. Disconnect the water return pipe and bracket from the turbocharger and the cylinder head (see Figure 8).
  - Remove the eye bolt from the turbocharger.
  - Remove the bolts from the pipe mounting clips.
  - Remove the fan guide bracket nuts.
  - Disconnect the “U”-shaped rubber hose from the water return pipe.

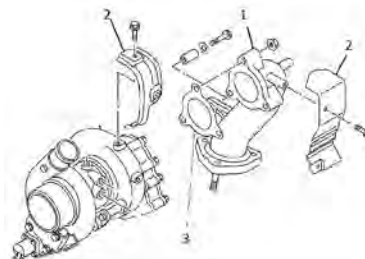
Figure 10

1. Exhaust Adapter
2. Heat Protector
3. Exhaust Adapter Gaskets

11. Remove the oil feed pipe (see Figure 9).
  - Remove the eye bolt from the turbocharger.
  - Remove the bolts from the pipe mounting clips.
12. Remove the turbocharger with the exhaust adapter (see Figures 6 and 10).
  - Remove the turbocharger clamping nuts (1).
  - Remove the exhaust adapter heat protector.
  - Remove the exhaust adapter mounting bolts (3).
