Mack Trucks, Inc.
Greensboro, NC USA

Field Service Bulletin Trucks

Power Take Off (PTO) Output Wire
CHU, CXU, GU, TD

FSB 371-043, Power Take Off (PTO) Output Wire

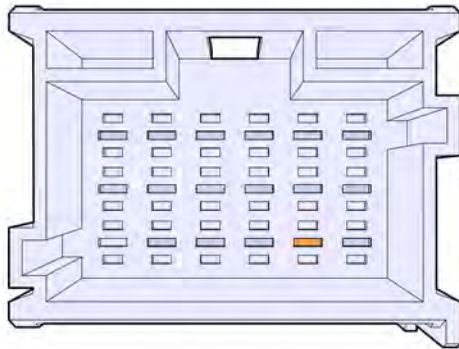
W3073819

On Mack trucks built between February 14, 2011 and July 2, 2012, with Body Link III. The PTO2 (Power Take Off) function may not work correctly. This is due to Vehicle Electronic Control Unit (VECU) PTO2 output wire, circuit CB7A, being in the wrong cavity location. If you experience this problem follow the procedure below to resolve the issue:

Cavity 15

- 5 Disconnect the black 18 pin connector from the green 18 pin connector.
- 6 Find wire CB7A located in cavity 15 on the black connector. Using extraction tool 9812475 (part of tool kit 8890037) or extraction tool 85131561 (part of tool kit 85131399) to remove the pins as instructed.

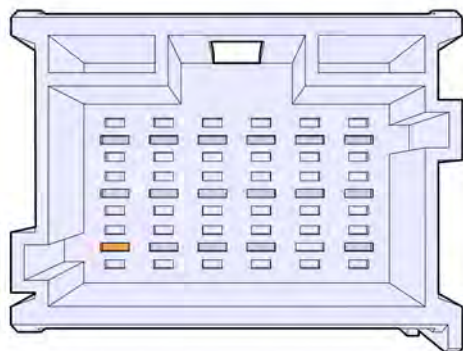
W3073821

Cavity 3

- 7 Install wire CB7A into cavity 3 on the black connector.
