Mack Trucks, Inc.
Greensboro, NC USA

Aftertreatment Diesel Particulate Filter (DPF)
Inlet Pipe

GU
Cummins ISL

PI0795, Aftertreatment Diesel Particulate Filter (DPF) Inlet Pipe

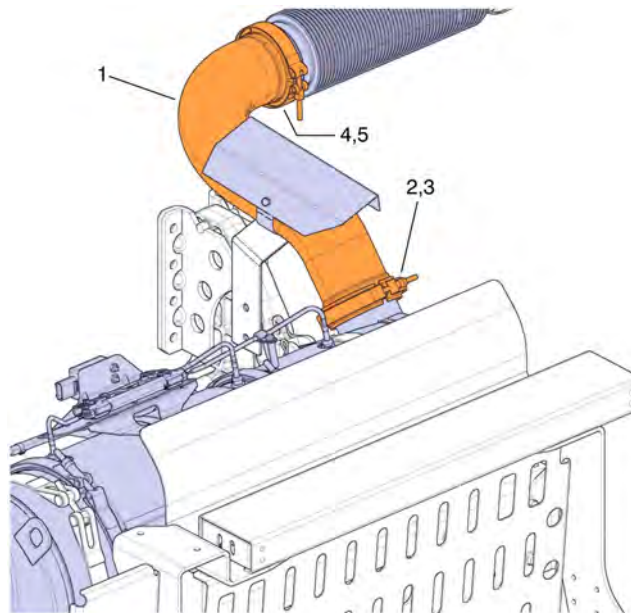
W2076382

Certain Mack GU trucks with the Cummins ISL engine built from 8-25-2011 to 4-11-2012 may exhibit an exhaust leak at the Aftertreatment Diesel Particulate Filter (DPF) inlet pipe. The DPF inlet pipe flange has been modified to improve the sealing function of the DPF inlet pipe. Trucks built between these dates should replace the DPF inlet pipe (21534291) with new inlet pipe (21921104). New gaskets are installed on both ends of the new DPF inlet pipe. Additionally, a new v-band clamp (21601828) is required to complete the installation.

DPF Inlet Pipe Parts			
Item #	QTY	Part Number	Description
1	1	21921104	Exhaust Pipe, DPF Inlet
2	1	21601828	V-Band Clamp, DPF Inlet Pipe to DPF
3	1	21601830	Gasket (DPF Inlet)
4	1	21095721	Gasket (Flex Pipe)
5	1	N/A	V-Band Clamp to Flex Pipe, Existing
