Mack Trucks, Inc.
Greensboro, NC USA

Service Program Trucks

PI0801, Huck Bolts Contacting Aftertreatment Control Module (ACM)

(August 2012)

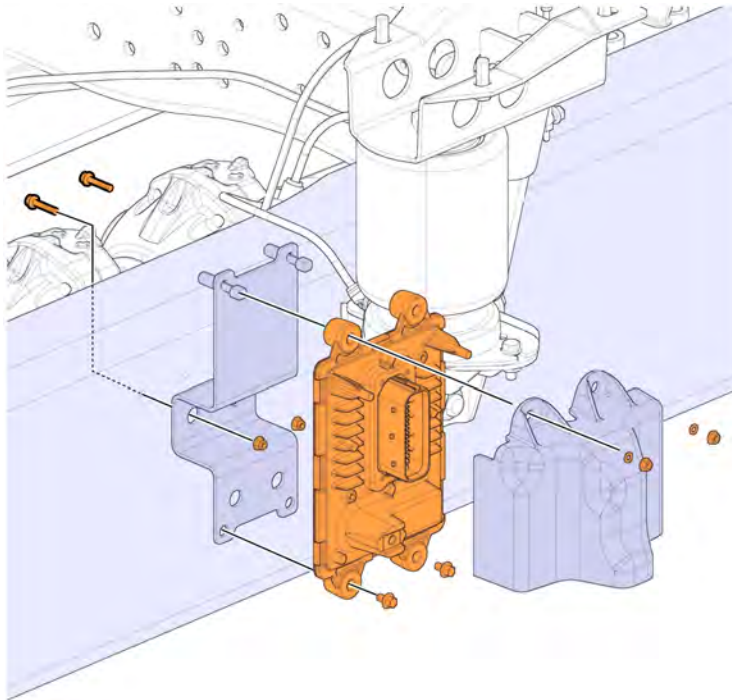
W3075897

On certain MACK GU vehicles there has been interference between the aftertreatment control module (ACM) and the two upper huck bolts for the fuel tank J bracket. If interference exists remove the ACM and cut off the end of the huck bolts to provide the necessary clearance. To repair this issue complete the following procedure.

- 1 Secure the vehicle for service by parking it on a flat level surface, applying the parking brake, chocking the rear wheel, and placing the transmission in neutral.
- 2 Disconnect all cables from the negative (ground) and positive battery terminals to prevent personal injury from electrical shock and prevent damage to electrical components.
- 3 Remove the aftertreatment control module (ACM) cover.
- 4 Remove p-clamp and disconnect the electrical harness from ACM.
- 5 Remove the ACM.
