Service Bulletin No. 390

MODEL E4500 / J4500 Series Coaches	TYPE Field Change Program	SECTION/GROUP 3 – Body	DATE Aug. 3, 2012
SUBJECT DRAIN HOLES IN DRIVE AXLE SUSPENSION SUPPORT STRUCTURE			
CONDITIONS

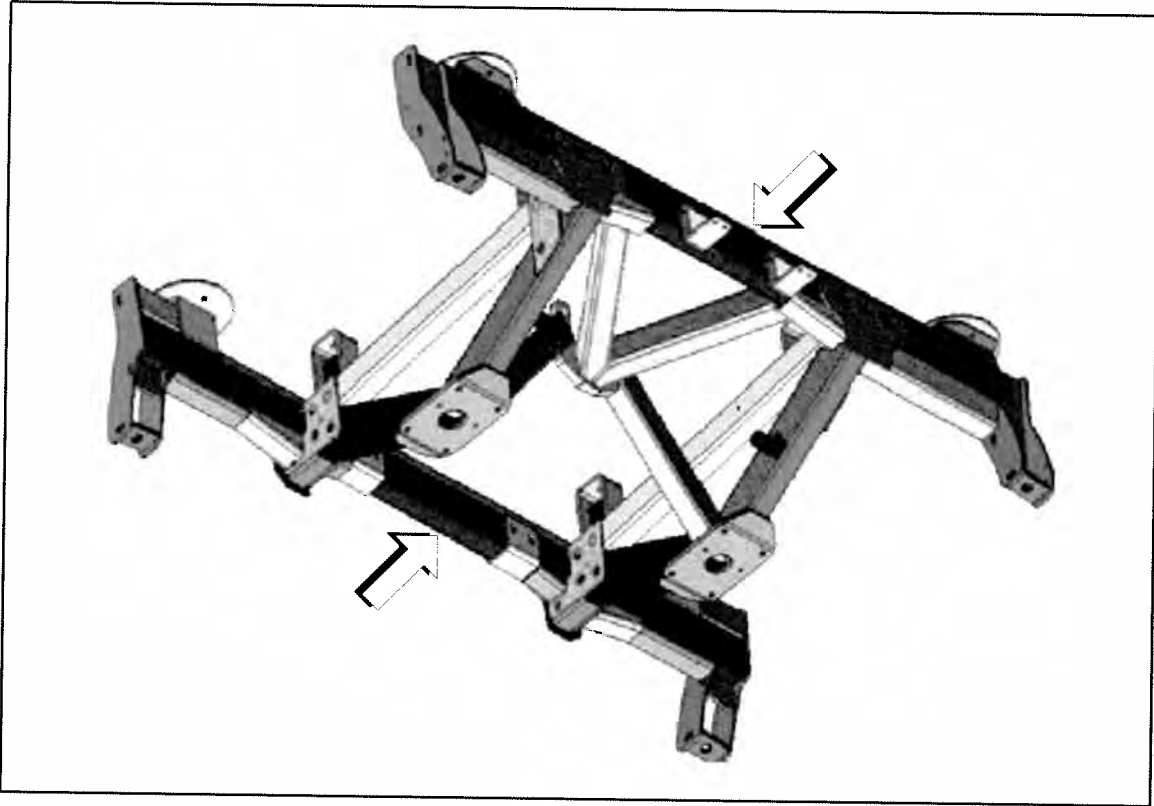
Figure 1. Drive axle support structure cross tubes.

- Using a caliper, measure a clean area of the outside fore–aft dimension on each of the two (2) drive axle support structure cross tubes.

In the event that either of the fore–aft measurements exceeds 3.18 inches, without the presence of rust, dirt or debris, or if a crack is present anywhere on either cross tube, contact the MCI Fleet Support Technical Center at 1-800-241-2947 for further information, before proceeding any further.
