**SUBJECT: Allison 3000RDS Automatic Transmission Oil Cooler
Hose Retaining Ring**

Department: Service
Section: Transmission
Model(s): 3000RDS ATM
Model Year(s): 2011 and After
Effective Date: 09/01/2012
Form #: TSB TR-27
Rev #: n/a
Supersedes: n/a

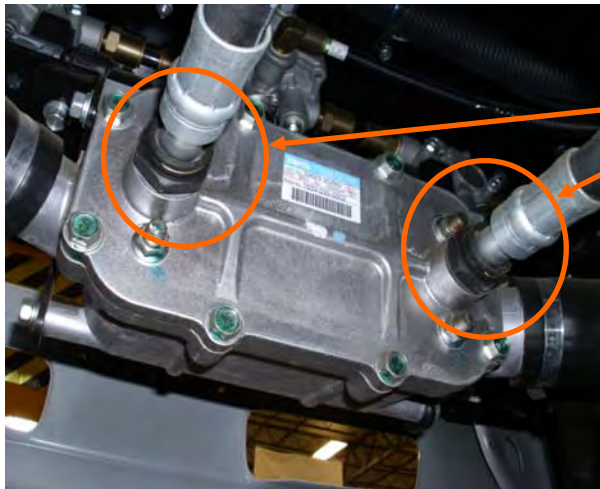
2011 MY and after UD2600 and UD3300 trucks equipped with the Allison 3000RDS automatic transmission may experience a fluid leak at the transmission oil cooler hose connection. This is a result of the cooler hose retaining ring disengaging.

Connector with retaining ring

It is recommended that a hose clamp be installed around each connector on dealer stock inventory vehicles and whenever a vehicle is brought in for routine service or repairs. The worm screw hose clamp should be installed around the connector as illustrated below.
