Service Bulletin

Bulletin No.: PIE0222

Subject: Engineering Information – Blower Motor Inoperative, No HVAC Airflow Through Vents

Models: 2011-2012 Cadillac Escalade, Escalade ESV, Escalade EXT
2011-2012 Chevrolet Avalanche, Silverado, Suburban, Tahoe
2011-2012 GMC Sierra, Yukon, Yukon Denali, Yukon XL, Yukon XL Denali

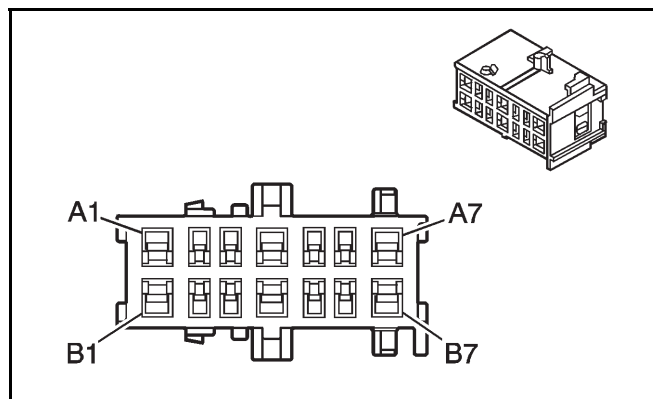
1667399

Use the following diagnostic and repair steps if the fault is determined to be caused by the X4 junction block.

2. Locate Pin A6, Circuit 754.
3. Perform a pin drag test using test probe J-35616-2A (GY).
4. If the terminal fails the pin drag test, replace the terminal for Pin A6. Refer to Junction Block - Right I/P X4 in SI.
5. Cut off the terminal between the core and the insulation crimp to minimize any wire loss.
6. To minimize wire loss, remove only the insulation required.
7. Position the stripped wire in the terminal.
8. Hand crimp the core wings first.
9. Hand crimp the insulation wings around the cable.
10. Solder the hand crimp terminal.

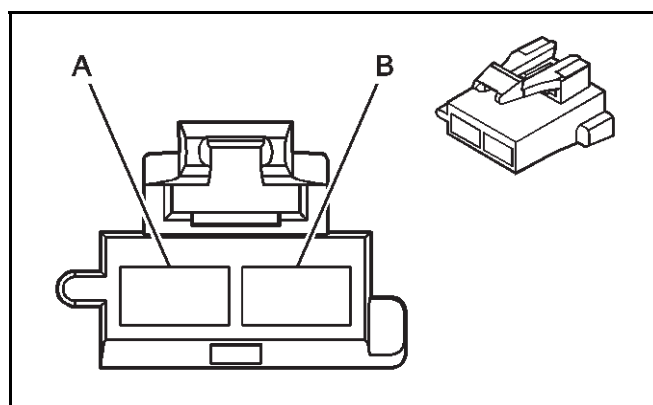
493694

Use the following diagnostic and repair steps if the fault is determined to be caused by the X6 junction block.

2. Locate Pin A, Circuit 542.
 3. Perform a pin drag test using test probe J-35616-42 (RD).
 4. If the terminal fails the pin drag test, replace the terminal for Pin A. Refer to Junction Block - Right I/P X6 in SI.
 5. Cut off the terminal between the core and the insulation crimp to minimize any wire loss.
 6. To minimize wire loss, remove only the insulation required.
 7. Position the stripped wire in the terminal.
 8. Hand crimp the core wings first.
 9. Hand crimp the insulation wings around the cable.
 10. Solder the hand crimp terminal.
- Reconnect the junction block.
