Service Bulletin

Bulletin No.: PIE0222A

Subject: Engineering Information – Blower Motor Inoperative, No HVAC Airflow Through Vents

Models: 2011-2012 Cadillac Escalade, Escalade ESV, Escalade EXT
2011-2012 Chevrolet Avalanche, Silverado, Suburban, Tahoe
2011-2012 GMC Sierra, Yukon, Yukon Denali, Yukon XL, Yukon XL Denali

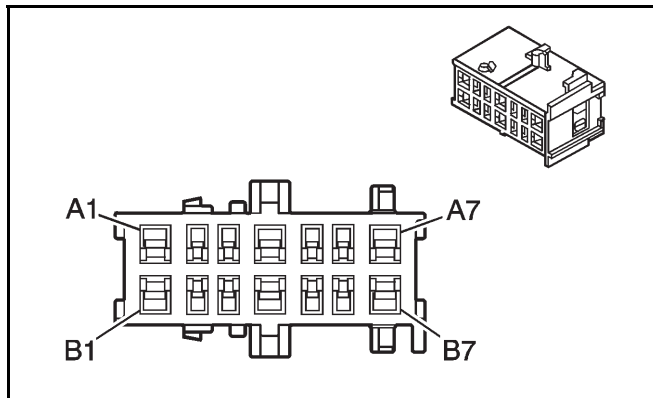
1667399

Use the following diagnostic and repair steps if the fault is determined to be caused by the X4 junction block.

1. Make sure there are no backed out or loose terminals using the appropriate Terminal Test Probe.

2. Locate Pin A6, Circuit 754.
3. Perform a pin drag test using test probe J-35616-2A (GY).
4. If the terminal fails the pin drag test, replace the terminal for Pin A6. Refer to Junction Block - Right I/P X4 in SI.
5. Cut off the terminal between the core and the insulation crimp to minimize any wire loss.
6. To minimize wire loss, remove only the insulation required.
7. Position the stripped wire in the terminal.
8. Hand crimp the core wings first.
9. Hand crimp the insulation wings around the cable.
10. Solder the hand crimp terminal.

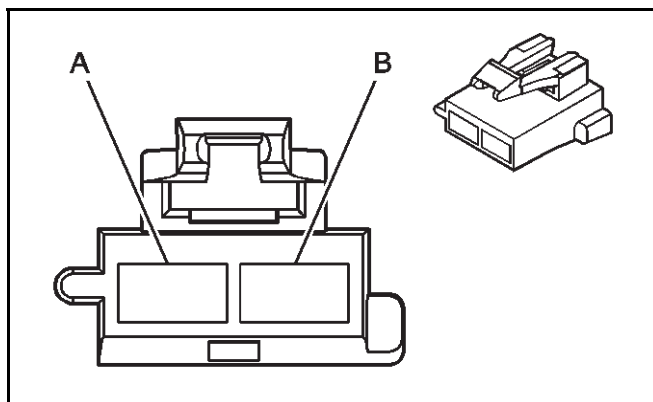
493694

Use the following diagnostic and repair steps if the fault is determined to be caused by the X6 junction block.

1. Make sure there are no backed out or loose terminals using the appropriate Terminal Test Probe.

2. Locate Pin A, Circuit 542.
 3. Perform a pin drag test using test probe J-35616-42 (RD).
 4. If the terminal fails the pin drag test, replace the terminal for Pin A. Refer to Junction Block - Right I/P X6 in SI.
 5. Cut off the terminal between the core and the insulation crimp to minimize any wire loss.
 6. To minimize wire loss, remove only the insulation required.
 7. Position the stripped wire in the terminal.
 8. Hand crimp the core wings first.
 9. Hand crimp the insulation wings around the cable.
 10. Solder the hand crimp terminal.
- Reconnect the junction block.
