DEALER SERVICE ACTION

2013 ALTIMA STEERING COLUMN NUT TORQUE

ID #: PC158

APPLIED VEHICLES: 2013 Nissan Altima

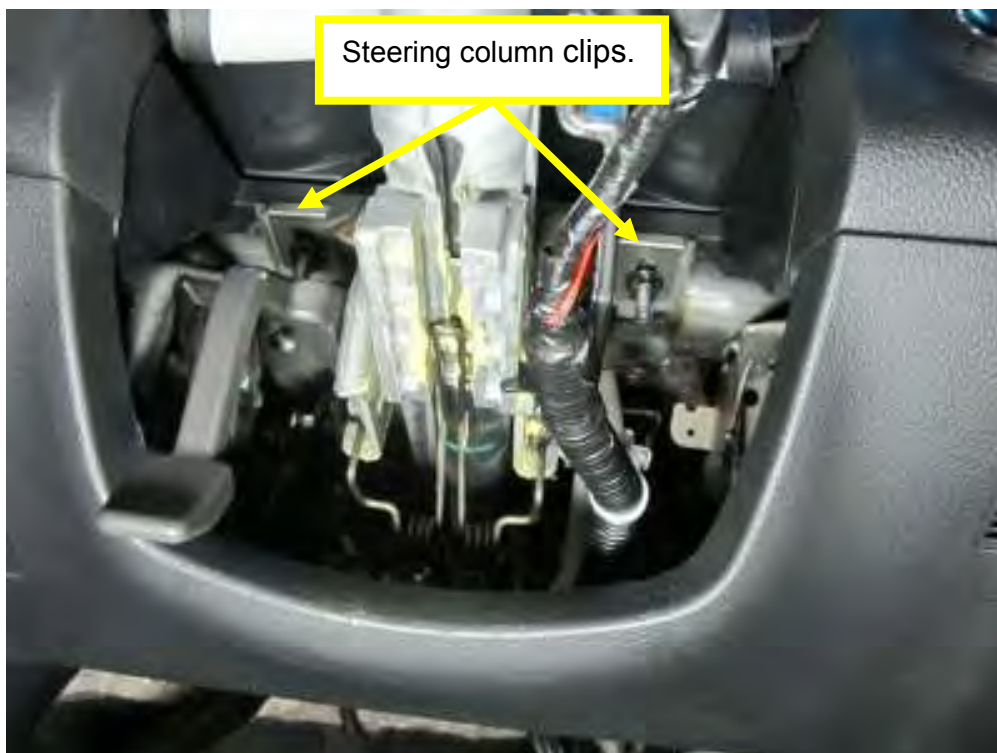
4. Inspect Steering column clip location.
 - Locate steering column clips.

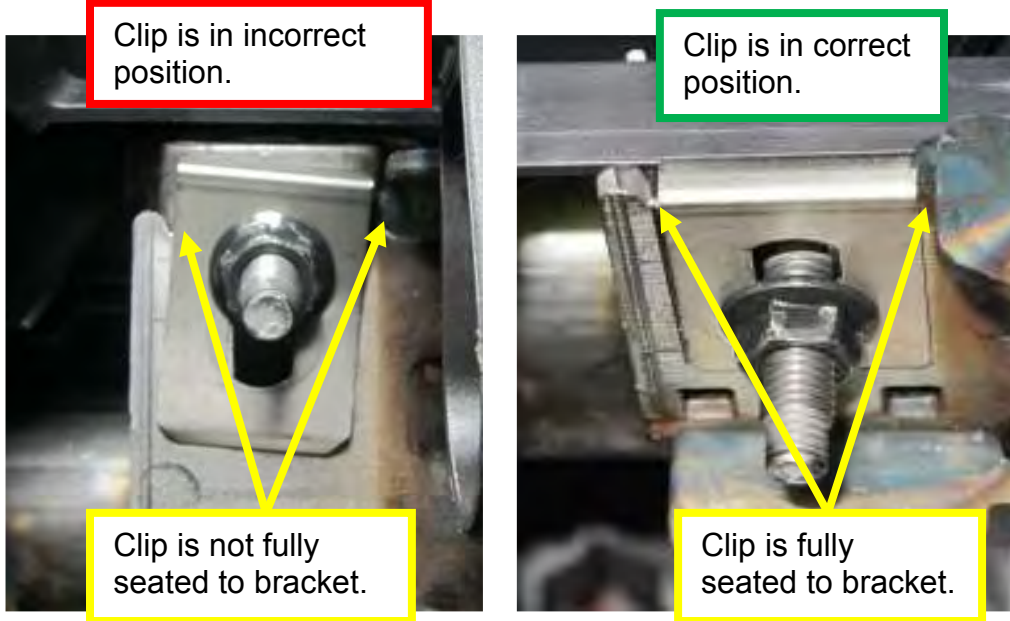
- Inspect to ensure clips are fully seated to bracket.

- If clips is in correct position and is fully seated to bracket go to step 6.
- If clips is in incorrect position and is '**NOT**' fully seated go to step 5.
