DEALER SERVICE ACTION

2013 ALTIMA STEERING COLUMN

ID #: PC156

APPLIED VEHICLES: 2013 Nissan Altima

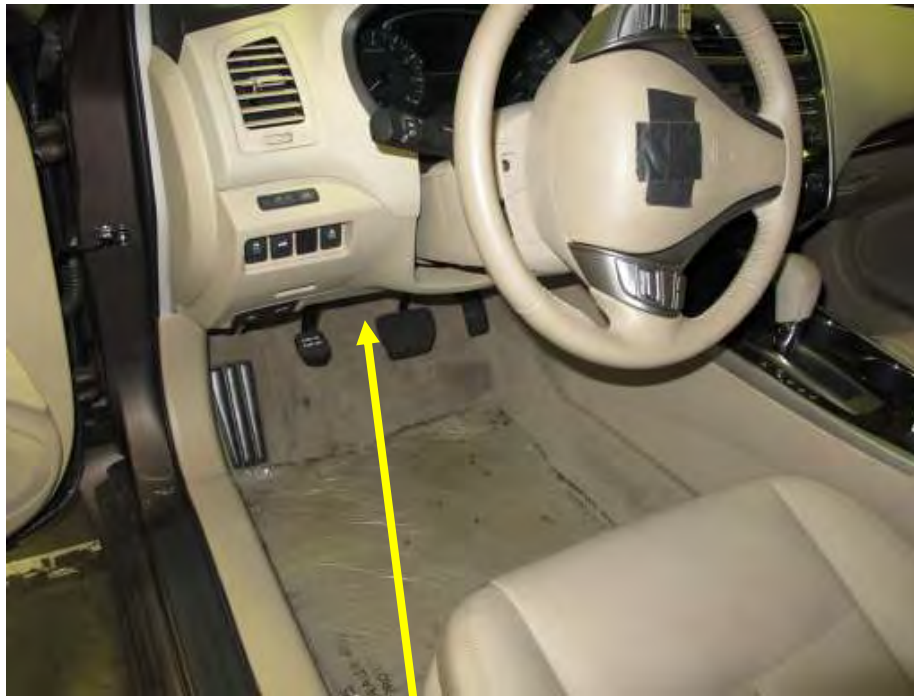
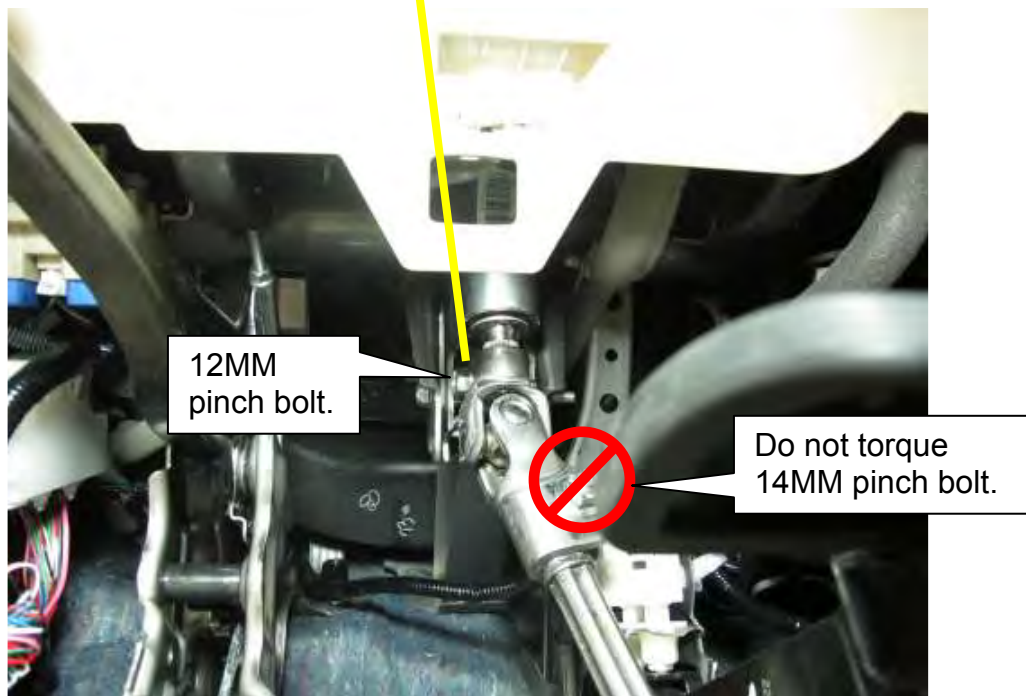
1. Open driver's door and locate the 12MM steering column pinch bolt.

2. Torque 12MM pinch bolt to 18.5 ft-lb (25 NM).
