2008-2013 MX-5

SB-10046279-1614

ENGINE STALL AND / OR NO START

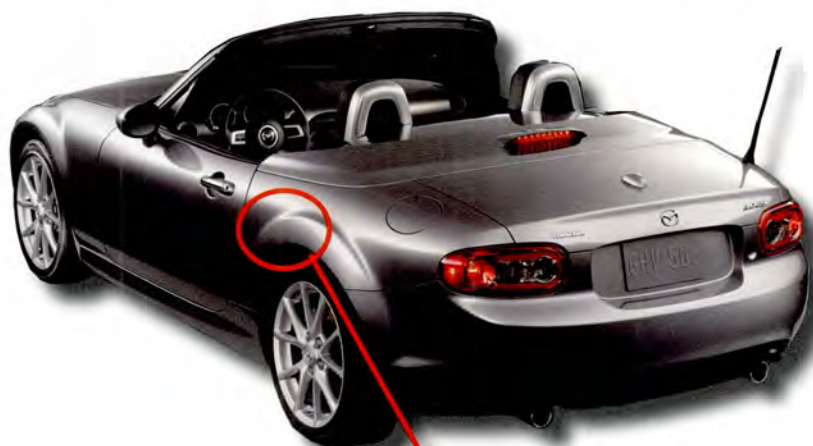
These concerns may be caused by an aftermarket electronic device (see image below).

Aftermarket electronic devices connected to the vehicle's wiring harness may interfere with the vehicle's CAN system and may cause an engine stall and/or no start condition.

Original Factory Power Retractable Hardtop Module

Aftermarket Hardtop Module

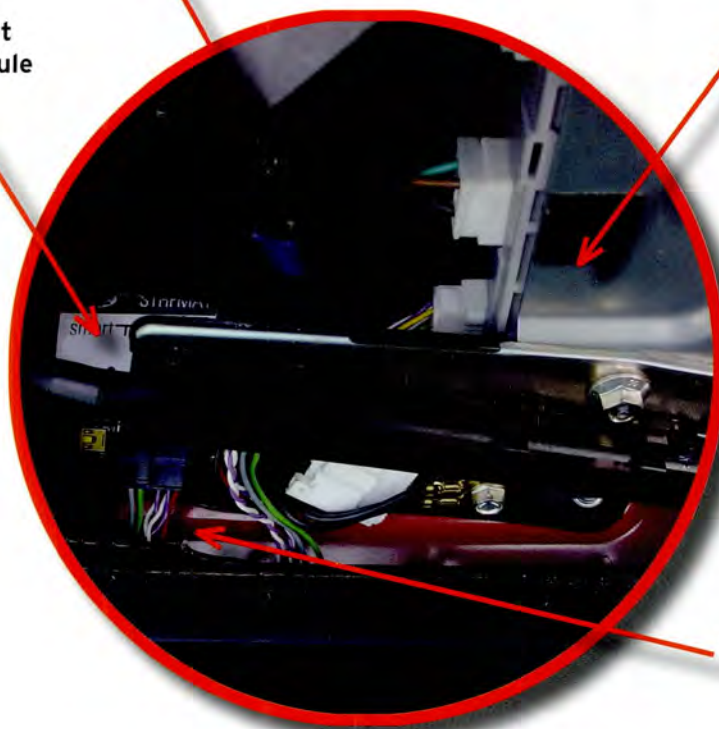
Aftermarket Hardtop Module Sub-harness
