2013 CX-5 SB-10046280-5689 START / STOP BUTTON AND / OR KEY WARNING INDICATOR LIGHTS COME ON INTERMITTENTLY

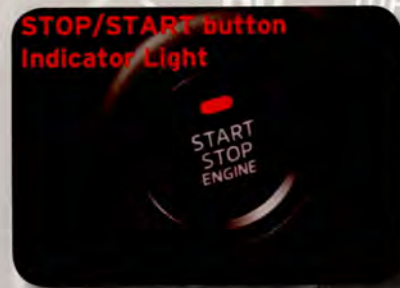
Accessory device
charger

This condition may be caused by an aftermarket accessory device charger (e.g., mobile phone charger). The charger may be producing electrical interference.

1. Remove the customer's accessory device charger from the vehicle's power outlet.
2. If the problem is no longer present, do not perform any repairs. Advise the customer to purchase a different brand device charger.

Note: Moving the vehicle Advanced Key away from the device charger may eliminate the concern.
