Service Bulletin

Bulletin No.: PI0785

Subject: DTC C027B, Low Brake Pedal Feel After Master Cylinder Repairs

Models: 2009-2013 Buick Enclave
 2010-2012 Buick LaCrosse
 2011-2013 Buick Regal
 2012-2013 Buick Verano
 2009-2013 Cadillac CTS, SRX
 2013 Cadillac ATS, XTS
 2009-2012 Chevrolet Colorado
 2009-2013 Chevrolet Corvette, Impala, Malibu, Traverse
 2010-2013 Chevrolet Camaro, Equinox
 2011-2013 Chevrolet Cruze
 2012 Chevrolet Captiva Sport
 2012-2013 Chevrolet Sonic
 2013 Chevrolet Spark
 2009-2012 GMC Canyon
 2009-2013 GMC Acadia
 2010-2013 GMC Terrain

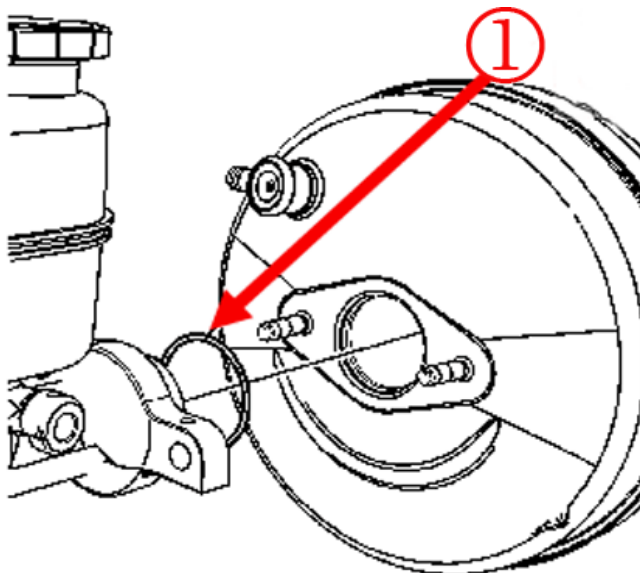
Some customers may comment on a low brake pedal during brake pedal apply. During diagnosis, a DTC C027B may be found stored in the EBCM. This concern may have started after the master cylinder was unbolted from the brake booster for any reason.

This may be caused by a small vacuum leak between the master cylinder and the brake booster. There is an O-ring between the master cylinder and the brake booster that may have fallen off during the prior repairs.

Inspect for the O-ring (1) between the master cylinder and the brake booster before performing any other diagnostics for the low brake pedal or the DTC C027B. Replace the O-ring if missing or damaged.

Tip: Exhaust the booster vacuum by either pumping the brake pedal or pulling the check valve out prior to removing the master cylinder. The suction may be helping to dislodge the O-ring when pulling the master cylinder out.
