Service Bulletin

Bulletin No.: PI0785A

Subject: DTC C027B, Low Brake Pedal Feel After Master Cylinder Repairs

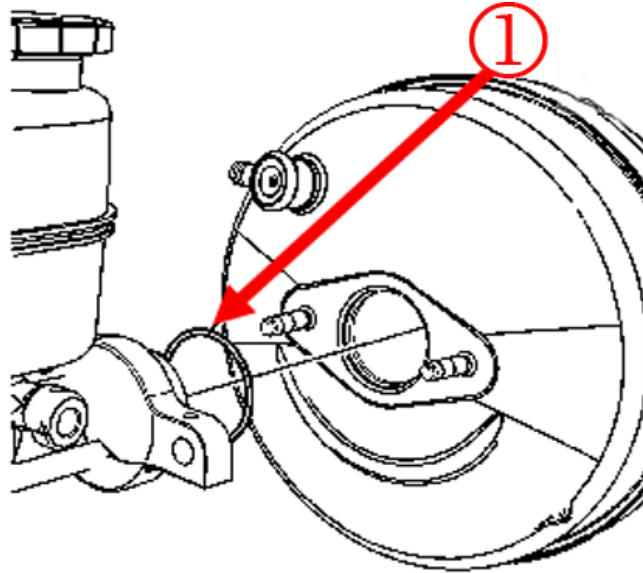
2515865

Some customers may comment on a low brake pedal during brake pedal apply. During diagnosis, a DTC C027B may be found stored in the EBCM. This concern may have started after the master cylinder was unbolted from the brake booster for any reason.

This may be caused by a small vacuum leak between the master cylinder and the brake booster. There is an O-ring between the master cylinder and the brake booster that may have fallen off during the prior repairs.

Inspect for the O-ring (1) between the master cylinder and the brake booster before performing any other diagnostics for the low brake pedal or the DTC C027B. Replace the O-ring if missing or damaged.

Tip: Exhaust the booster vacuum by either pumping the brake pedal or pulling the check valve out prior to removing the master cylinder. The suction may be helping to dislodge the O-ring when pulling the master cylinder out.
