**SB-10046580-4089**

IK0800389

**Title:** Steering harness rub possibly causing cruise to randomly drop out**Applies To:** Prostar**DESCRIPTION**

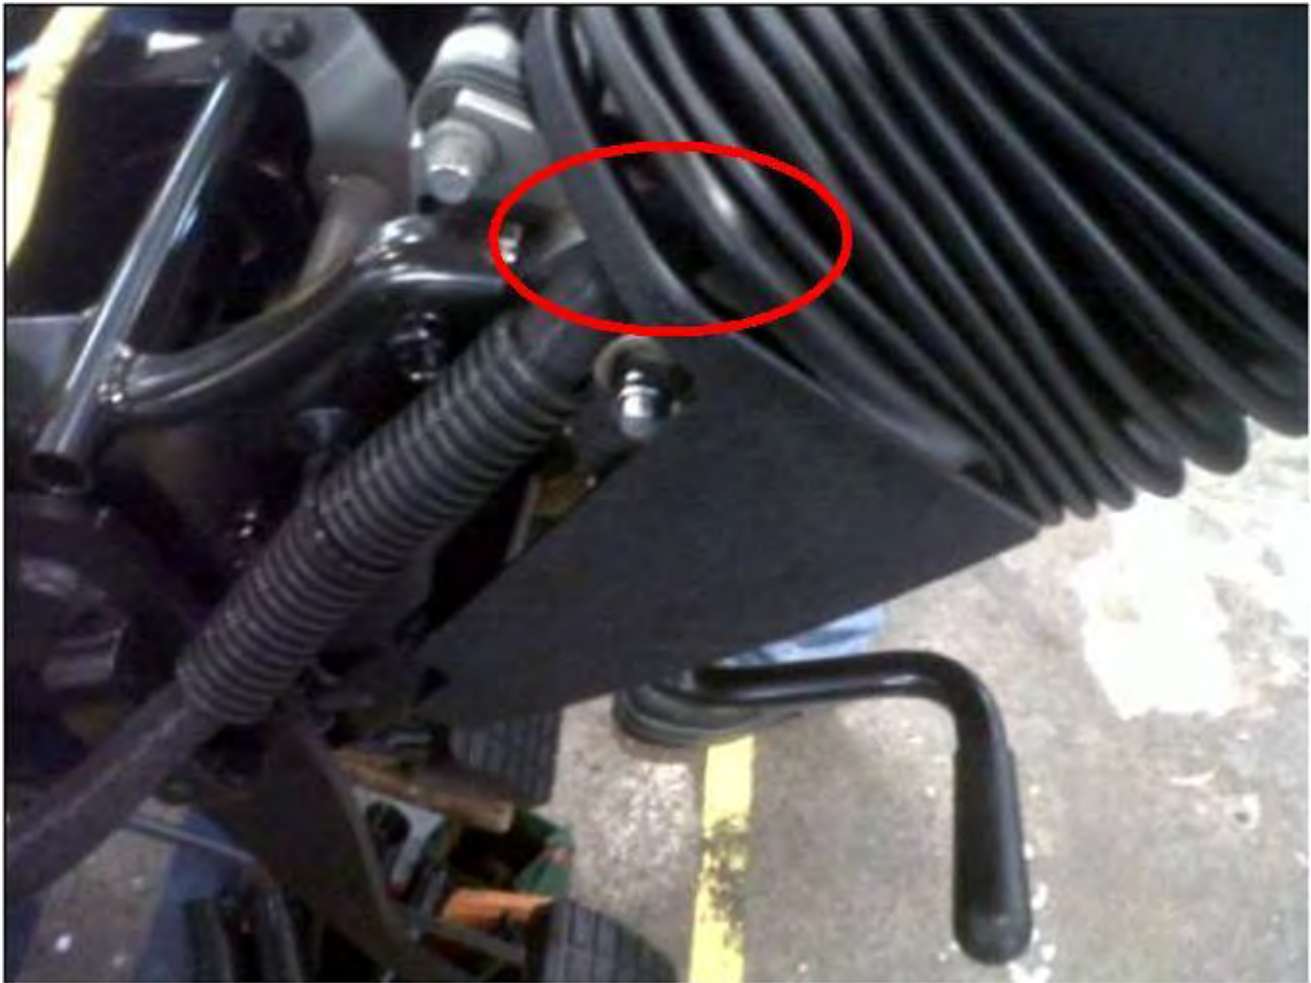
Figure 1

1. Remove steering column covers to view area in figure 1. If harness has rubbed through points indicated in figure 2 replace.

Replace harness

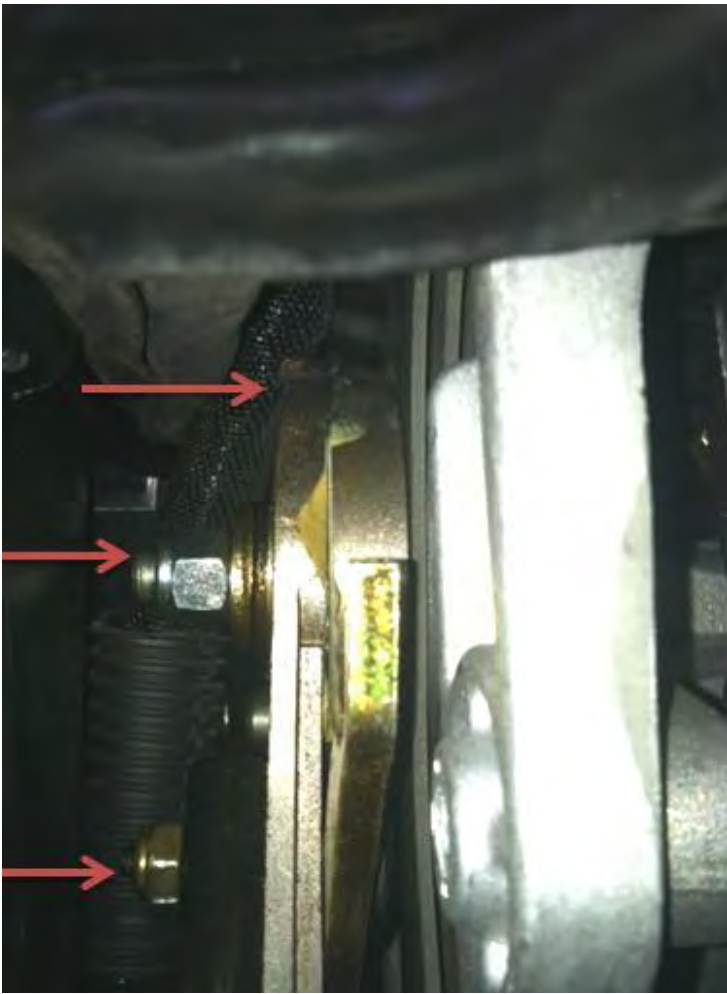
Figure 2.

Steering column harness rub may cause cruise wires from switches to momentarily short out turning off cruise.
