**SB-10046580-8799**

**Title: Steering harness rub possibly causing cruise to randomly drop out****Applies To: Prostar**

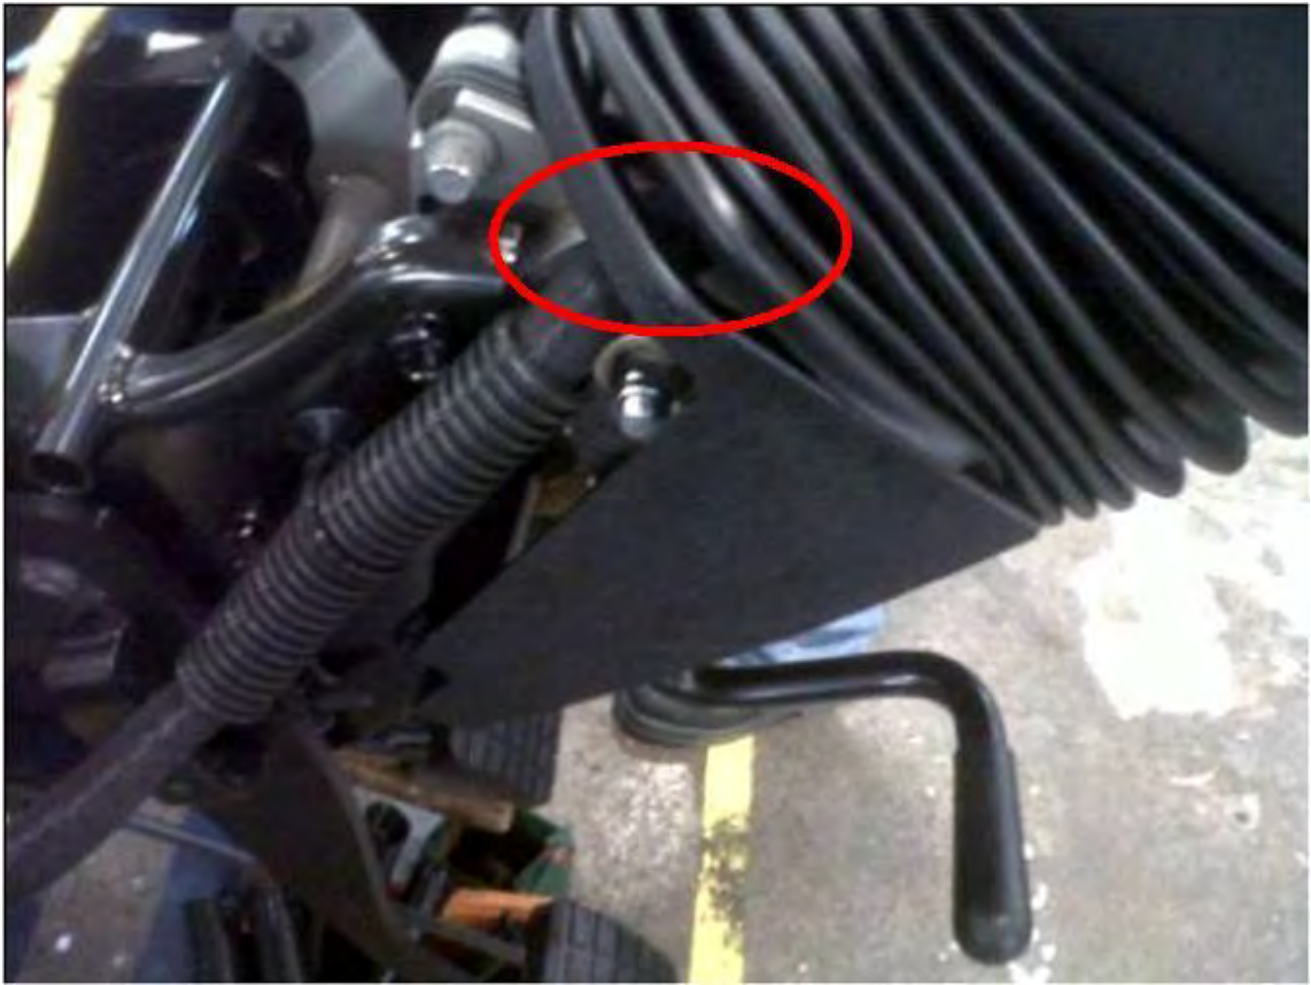
Figure 1

Steering column harness rub may cause cruise wires from switches to momentarily short out turning off cruise.

1. Remove steering column covers to view area in figure 1. If harness has rubbed through points indicated in figure 2 replace.
