SB-10046721-6695

SI B61 25 12
General Electrical Systems

ActiveE: Routing of the EPS Harness

E82E (ActiveE)

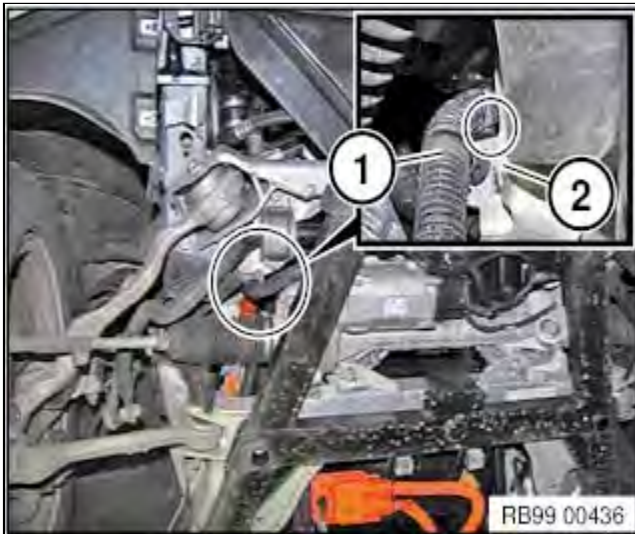
1. The EPS harness (1) must be positioned away from the sub-frame member (2).

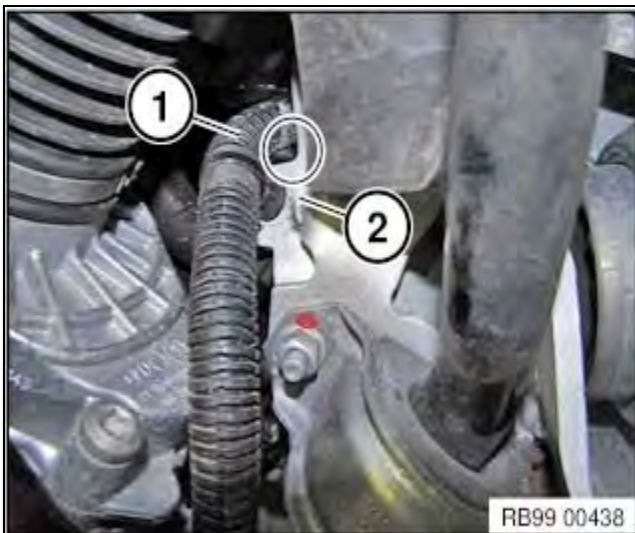
2. The correct distance (circled area) between the EPS harness (1) and the edge of sub-frame assembly (2) must be between 5 and 8 mm.
