## Unintended Wiper Cycling

54-189

Coronado  
> Business Class M2  
Cascadia  
108SD/114SD

Freightliner  
Service Bulletin

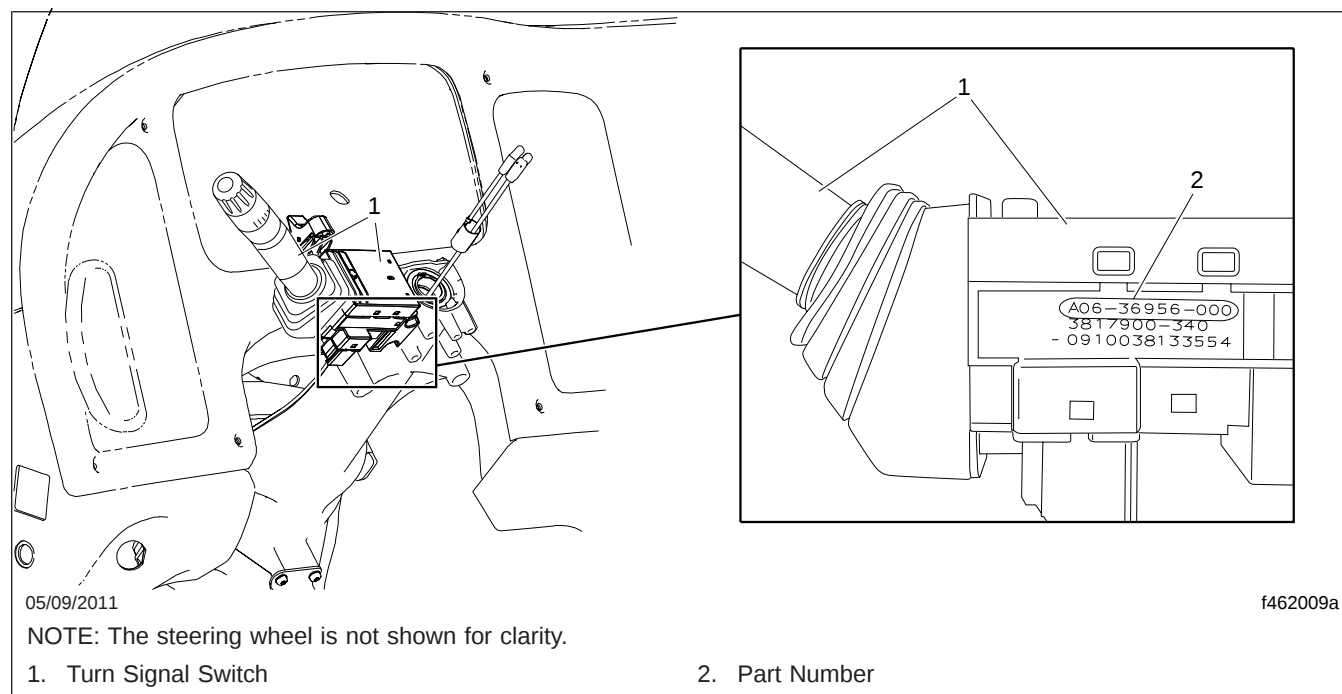
**Fig. 1, Steering Column Clamshell Cover Assembly Removed**

1. Park the vehicle, shut down the engine, set the parking brakes, and chock the tires.
2. Locate the part number on the multifunction turn signal switch. See [Fig. 1](#).

- 2.1 Remove the steering column clamshell cover assembly by removing the four screws that hold it together.
- 2.2 Check the part number stamped on the lower surface of the switch.
- 2.3 If the part number is A06-36956-000 or A06-36956-002, go to the next step.
