SI M17 06 12  
Cooling SystemsDecember 2012  
Technical Service

This Service Information bulletin supersedes SI M17 06 12 **dated October 2012.**

**SUBJECT****Service Action: Retrofit of the Engine Coolant Temperature Sensor****MODEL**

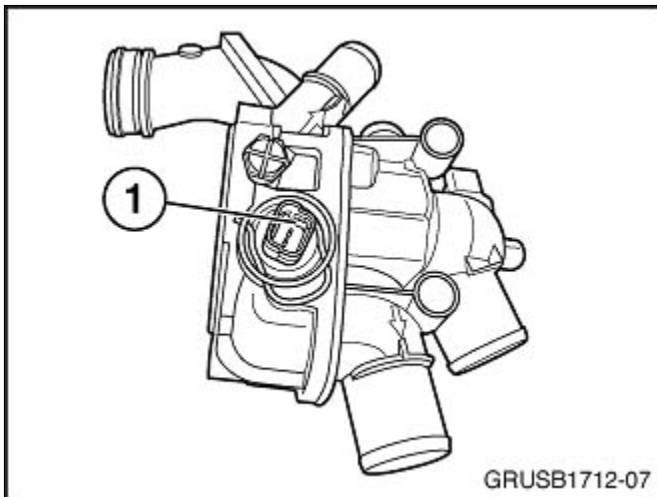
Checking for the updated thermostat:  
The 11 53 7 534 521 thermostat has a replaceable engine temperature sensor (1).

- Replace the engine wiring harness with the 11 53 7 534 521 thermostat.
- Do not install the remote engine temperature sensor. Claim the labor operation “Check for 11 53 7 534 521 thermostat installation” in the Warranty Information section of this bulletin.
- Affix the Service Action label to the B-pillar.
