SI B16 07 12
Fuel Supply SystemsOctober 2012
Technical Service

Service Action: Replace the Left and Right Fuel Level Sensor

E70 with N52K, N62TU and S63 engines

E71 with N54, N63 and S63 engines

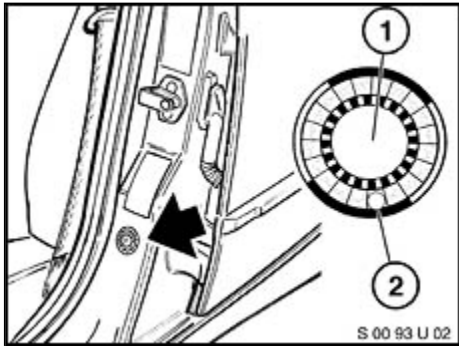
This Service Action has been assigned code number **633**. After the vehicle has been checked and/or corrected, obtain a label (SD 92-417) and:

- A. Emboss your BMW center warranty number in the middle of the label (1);
- B. Punch out code number **633** (2), printed on the label; and
- C. Affix the label to the B-pillar as shown.

If the vehicle already has a label from a previous Service Action, affix the new label next to the old one. Do not affix one label on top of another one because a number from an underlying label could appear in the punched-out hole of the new label.
