SI B61 24 12
General Electrical Systems

ActiveE: Routing of the HV Cables - Maintenance Service, Vehicle Check

E82E (ActiveE)

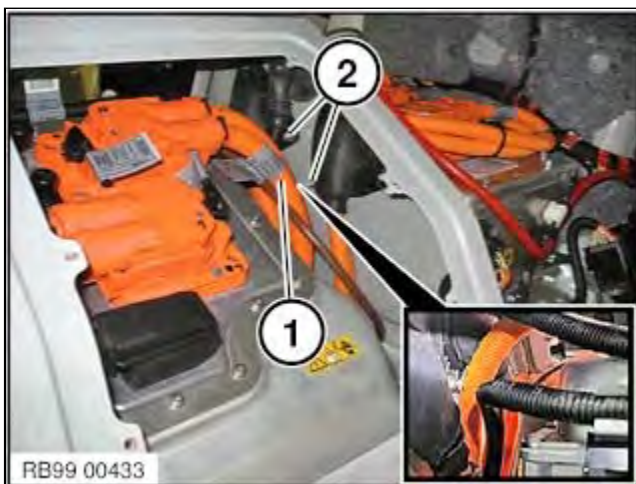
If the EME HV cables are re-routed incorrectly, they may contact the exposed fasteners in the rear right wheel housing area. Possible damage to the cable insulation can occur, resulting in various insulation fault codes stored in the EME control module.

1. When reinstalling the EME/E-motor assembly after the greasing service, make sure that the HV cables (1) are not in contact with the M10 (2) nuts (approximately 1" of clearance is required) from the cable ducts on the right wheel housing.
