# Technical Bulletin

TSB No. TS 39 08258

**SUBJECT: TRAILER TURN SIGNAL AND STOP LAMPS INOPERATIVE OR STAY ON AFTER INSTALLING ACCESSORY TRAILER HITCH**

**MODEL(S): XL7 (JC636)**

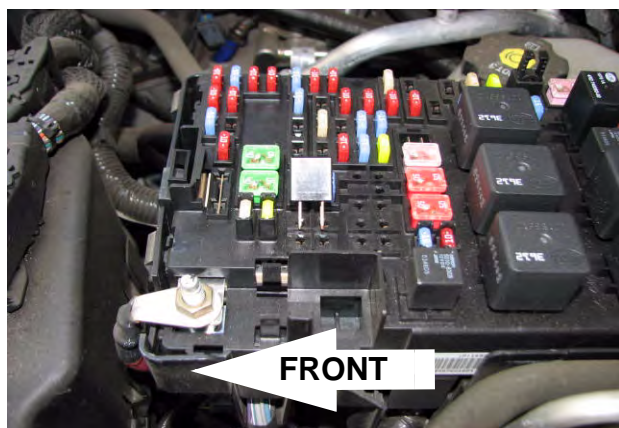
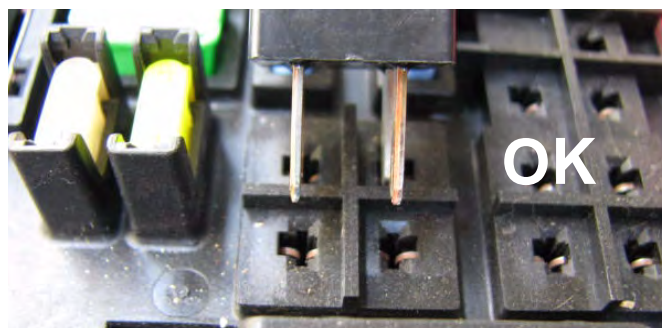
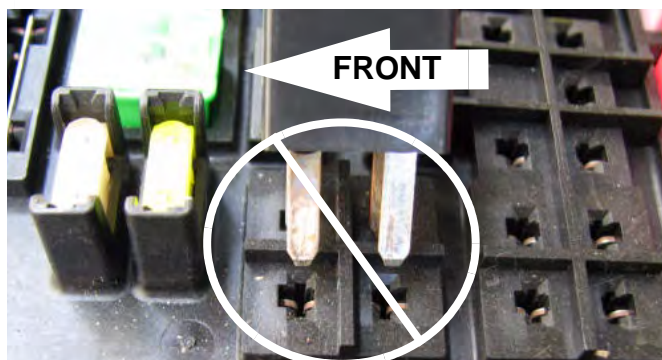
**CONDITION:** After installing accessory Trailer Hitch 990B0-26005 with Harness Kit 990B0-26006, it may be found that the trailer turn signal and stop lamps are inoperative or stay on at all times.

**CAUSE:** The lamp relays have been installed incorrectly.

**NOTE: The relay can be installed 4 different ways. Only two of the positions will function correctly. Make sure the relay blades insert into the relay box as shown. The relay will operate properly 180 degrees from the position shown below.**

**The relay will not operate properly if it is inserted 90 degrees from the correct position.**

**CORRECTION:** Check for proper installation of the "RT TRLR STOP/TRN" and "LT TRLR STOP/TRN" relays. Refer to picture below.
