# RECALL CAMPAIGN BULLETIN

NTB12-092

## VOLUNTARY EMISSIONS RECALL CAMPAIGN 2009 ALTIMA SEDAN AND COUPE ECM REPROGRAM AND MANIFOLD CATALYST

**CAMPAIGN ID #:** PC130**APPLIED VEHICLE:** 2009 Altima Sedan and Coupe (C/L32)  
with SULEV (California Specification) 2.5 engine

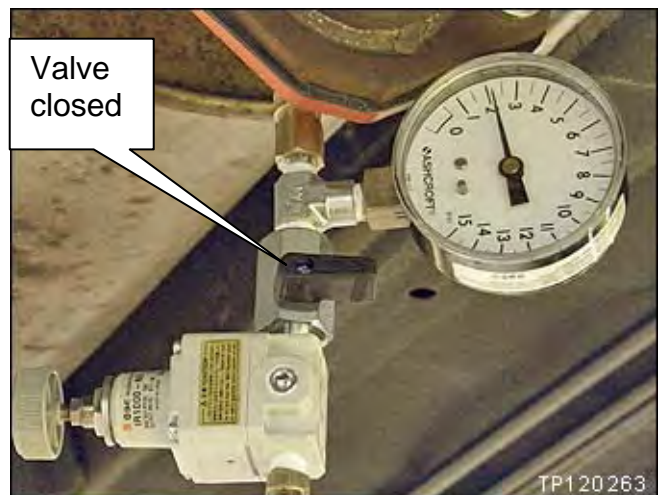
Figure P10

- a. Turn the valve to the closed position.
- b. The pressure will start to drop.
- c. When pressure drops to 5 PSI, begin a 20 second count.
- d. At the end of the 20 second count, read the pressure.

**OK: Pressure is 2 psi or above;** there is no leak in the front tube or manifold.

**NG: Pressure is below 2 psi;** there is a leak in the front tube, manifold, or gasket.

- If vehicle has **more than** 50,000 miles, go to Exhaust Manifold Replacement on page 13.
- If vehicle has **less than** 50,000 miles:
  - Remove the exhaust manifold stay – see page 10.
  - Reinstall the front exhaust tube.

B. Replace **only** the leaking part (gasket, front exhaust tube, and/or exhaust manifold).

- For all vehicles with **more than 50,000 miles**, **replace the exhaust manifold** even if it does not have a leak.
- Replacement of the exhaust manifold includes removal of the exhaust manifold stay.
  - For a leak at the gasket between the exhaust manifold and front tube; refer to page 11 (**Front Exhaust Tube Replacement**) and replace only the gasket.
  - For a leak at the gasket between the exhaust manifold and engine head; refer to page 13 (**Exhaust Manifold Replacement**) and replace only the gasket.
  - For a leak in the front tube; refer to page 11 (**Front Exhaust Tube Replacement**).
  - For a leak in the exhaust manifold; refer to page 13 (**Exhaust Manifold Replacement**).
