Service Bulletin

Bulletin No.: PI0826

Subject: Water Intrusion in Left and/or Right Front Passenger Compartment Floor

Models: 2012-2013 Chevrolet Sonic
Condition/Concern

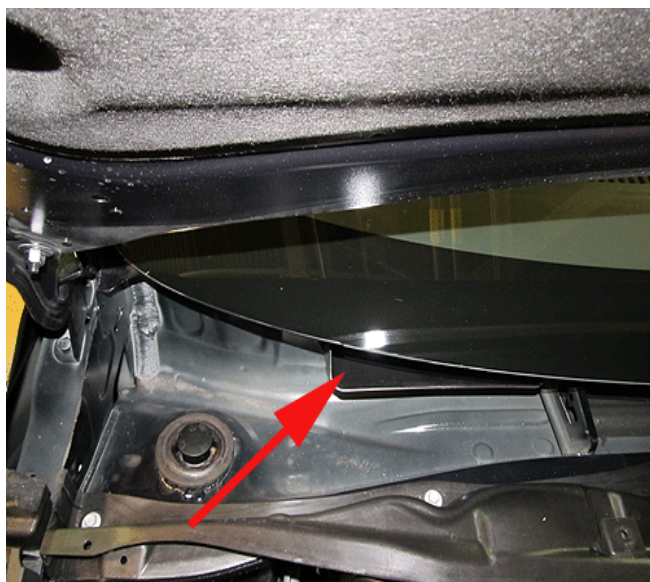
2912566

Some customers may comment that the front foot well carpet is wet. This condition is most prevalent when the vehicle is parked on an incline and the right front of the vehicle is elevated.

This condition may be caused by water intrusion through the HVAC fresh air inlet assembly, located in the plenum at the base of the windshield. The water may be flowing along the edge of the front windshield glass and dripping into the fresh air inlet. If the water intrusion is in this area, the passenger compartment air filter may also be saturated.
