Service Bulletin

Bulletin No.: PI0813

Subject: Driver Airbag Light Flashing and/or Passenger Airbag ON Indicator Does Not Illuminate with Passenger Present After SDM Reprogramming

Models: 2012 Chevrolet Camaro
2013 Chevrolet Malibu

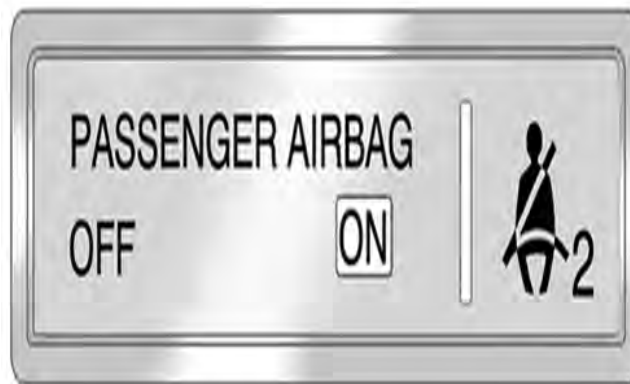
2906256

Passenger Airbag Indicator (Camaro)
