Service Campaign 63-01

AFFECTED: Certain 2013 Winnebago Adventurer, Journey, Tour and Itasca Suncruiser, Meridian and Ellipse Model Motorhomes Equipped With a Lippert Bed Lift Control Module

DATE: November 2, 2012

SUBJECT: Bed Lift Control Module Replacement

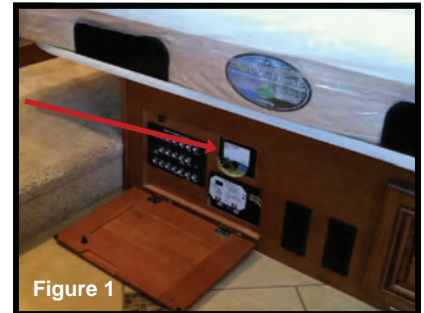
Winnebago Industries is conducting a Field Service Campaign to replace the Revision A bed lift control module. It has been determined that if the coach batteries become discharged slowly over time, it can cause the module to lose its IN/OUT stop settings. If the room is operated without these stop settings, it is possible to over-travel the room and cause damage to trims. The replacement 'REV B' module has a built in protection against this type of failure.

1. Locate the LCI bed control (15001-A) under the bed platform at the foot of the bed. (Figure 1) Disconnect the positive wire, ground wire, up, down and motor connector wiring. (Figure 2)
2. Install new revision control (15001-B). Connect motor wires, up, down, positive wire and then ground wire. (Figure 2)
