# Service Bulletin No. 389

| MODEL<br><b>D / E / J Series Coaches</b> | TYPE<br><b>Field Change Program</b> | SECTION/GROUP<br><b>7 – Electrical</b> | DATE<br><b>Oct. 12, 2012</b> |
| SUBJECT<br><b>RETENTION NUT ON LEECE NEVILLE ALTERNATOR</b> | | | |

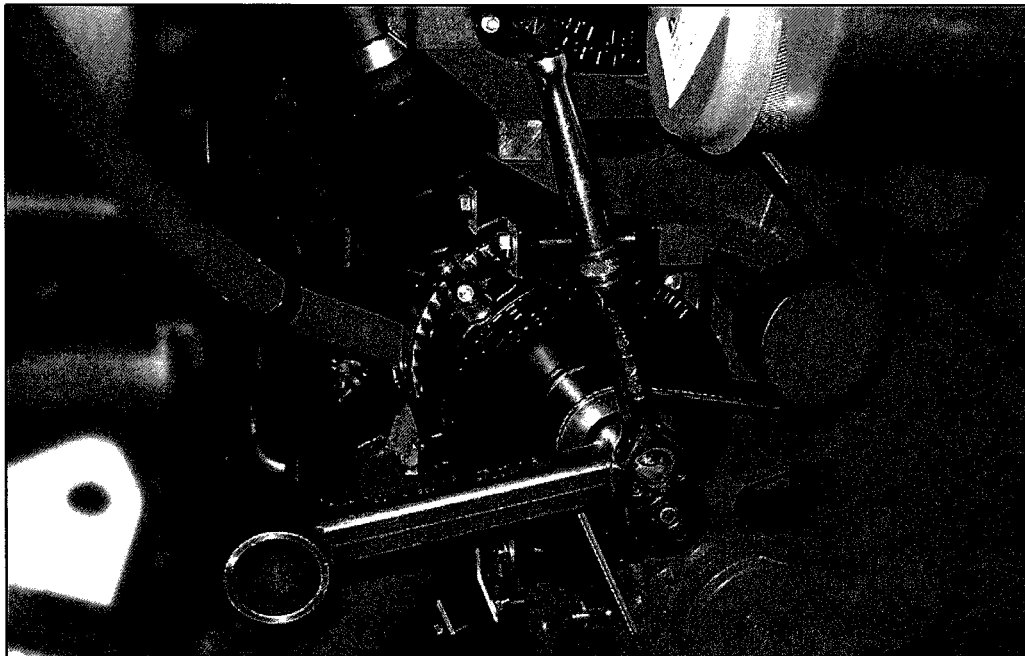
It has come to the attention of Motor Coach Industries, Inc. ("MCI") that the retention nut utilized on the Leece Neville alternator pulley installation is not maintaining the proper torque. The existing retention nut may result in alternator bearing failure.

Wrong retention nut for specific application.

9. Using the two ( 2 ) reference tools shown in Figures 5 and 6 simultaneously, remove and discard the existing pulley nut from the alternator.

10. Install and tighten the new nut, p/n 07-03-1285, on the alternator. Torque nut to 70– 80 ft.-lbs.
11. Repeat Steps 9. and 10. to the second alternator.
