Program Bulletin

CUSTOMER SATISFACTION PROGRAM

SUBJECT: Transmission Dipstick Tube Fracture

MODELS: 2010-2011 Cadillac Escalade, Escalade ESV, Escalade EXT
2010-2011 Chevrolet Avalanche, Silverado, Suburban, Tahoe
2010-2011 GMC Sierra, Yukon, Yukon XL
Equipped with Active Fuel Management

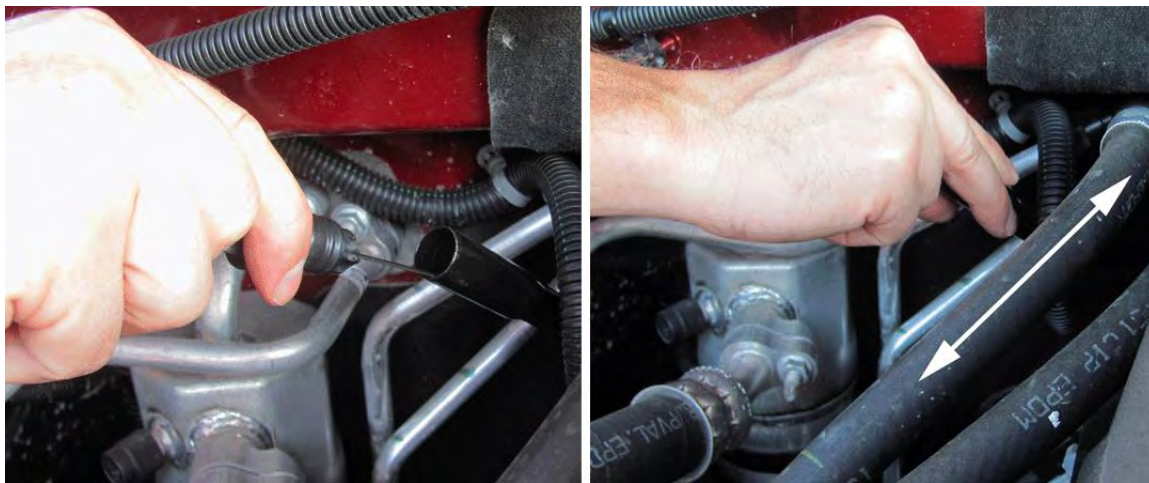
2906255

3. Grasp the transmission filler tube with your thumb and first two fingers of your right hand. Your thumb should be on the passenger side of the transmission filler tube and parallel to the filler tube.

4. Using only your thumb and the first two fingers of your right hand, force the transmission filler tube toward the driver's seating position and then back to the passenger's front wheel two times.

5. Determine if the transmission filler tube is damaged. An undamaged transmission filler tube will move less than two inches and spring back to its original position, while a damaged transmission filler tube will move greater than two inches and will not spring back to its original position. A damaged transmission filler tube will likely crack during this inspection.

- If the transmission filler tube is not damaged, proceed to Step 6.
 - If the transmission filler tube is damaged, replace the transmission filler tube. Refer to *Transmission Fluid Filler Tube and Seal Replacement* in SI.

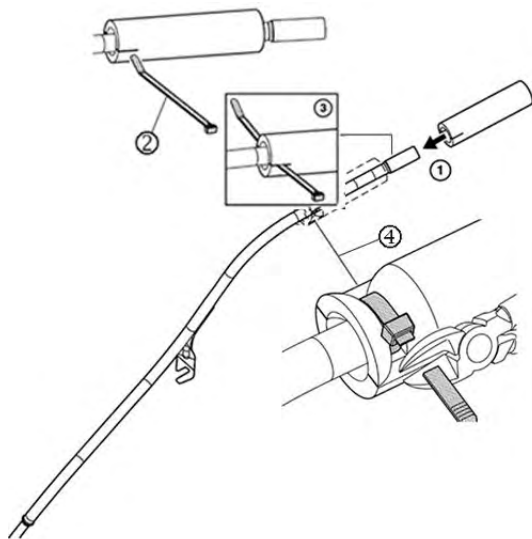
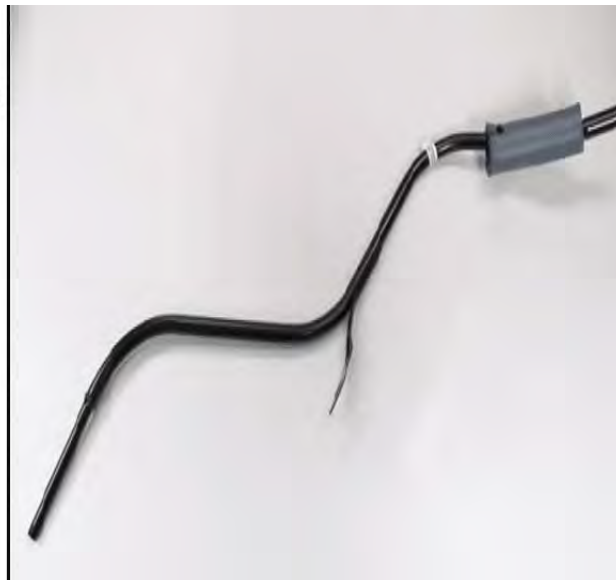
2906258

Note: The tie strap threads between the fill tube and half the foam damper using the slot in the sleeve. This is secured to the top half of the tube, leaving the lower half of the damper free.

7. Install a foam damper (sleeve) on the upper end of the transmission filler tube using a tie strap. Refer to illustration.
8. Install transmission dipstick.
9. Close hood.
