# Technical Service Bulletin

## 43 Self-leveling compressor inoperative

43 12 11 2018765/7 October 29, 2012. Supersedes Technical Service Bulletin Group 43 number 12-08 dated February 2, 2012 for reasons listed below.

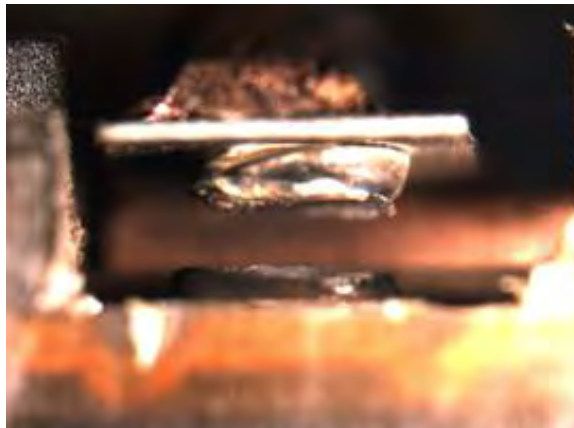
*Figure 1. Strong erosion of both contacts.*

If the relay resembles Figures 1 to 3, replace the compressor and relay J403 for the self-leveling system.

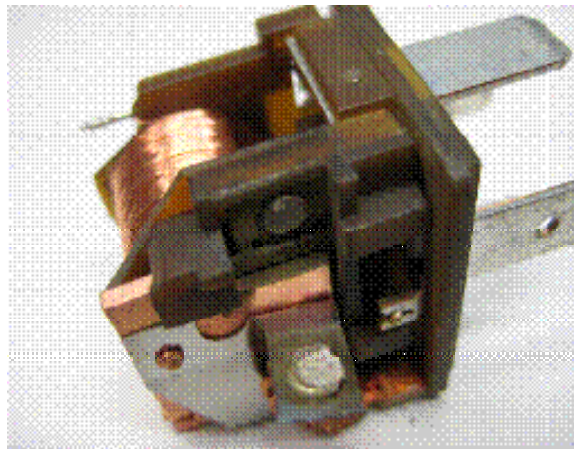
*Figure 2. Strong erosion of both contacts.*

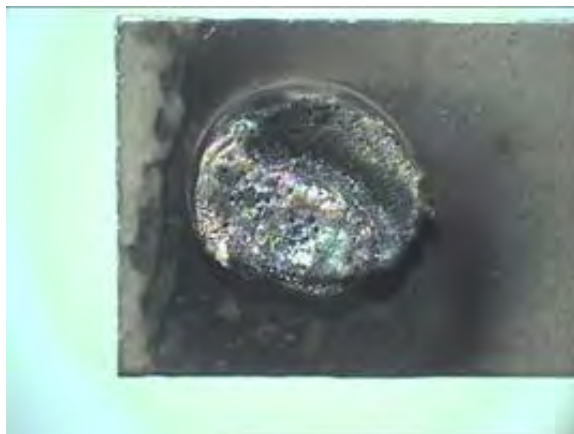
*Figure 3. Strong erosion of the spring contact.*

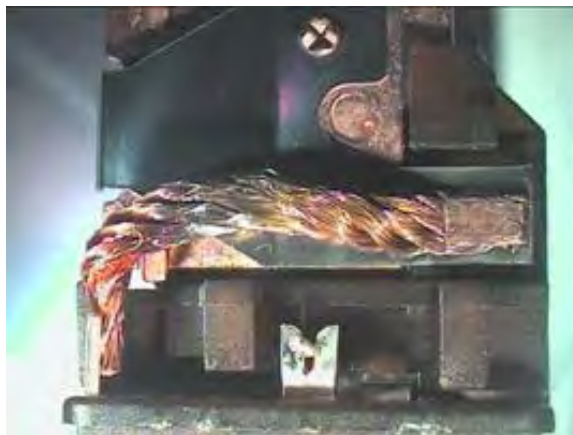
5. Discoloring of the strand is also a clear indication of permanent operation of the compressor (Figure 4).

*Figure 4. Overheated strand.*

Replace the compressor and relay J403 for the self-leveling system.

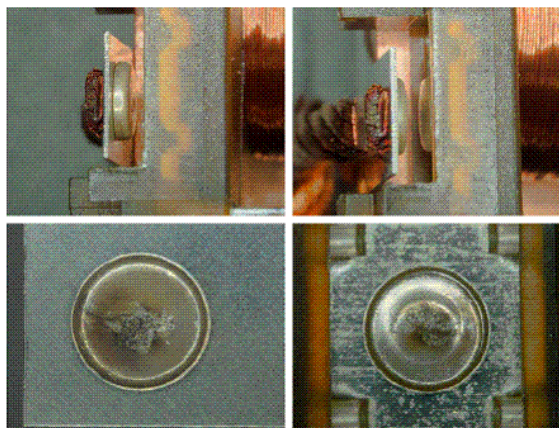
*Figure 5. Contacts with minor marks; relay OK.*

6. If the contacts resemble those in Figure 5 and the compressor has a working noise similar to a comparable vehicle, replace *only* the opened relay J403 for the self-leveling system.
