Technical Service Bulletin

48 Power steering warning in cluster, DTC for end stops

48 12 34 2029622/2 October 23, 2012. Supersedes Technical Service Bulletin Group 48 number 12-27 dated May 29, 2012 for reasons listed below.

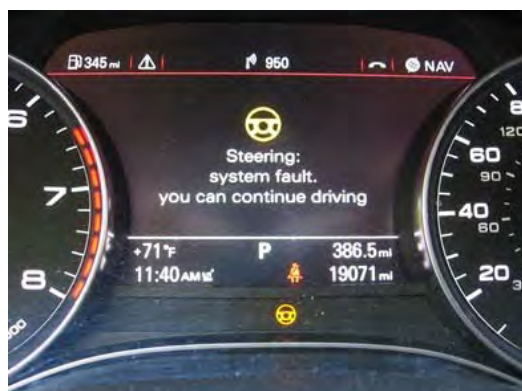
The yellow steering symbol is illuminated in the instrument cluster. A DTC *C10ACFO – steering end stops not programmed* is stored in address word 44 power steering (J500).

Figure 1. Yellow steering symbol and cluster message.

The steering control unit J500 expects to receive a VIN message over the data bus shortly after terminal 15 is turned on. If the VIN message is not received at the expected time, the J500 assumes it has been installed in a new vehicle and discards the programmed end position values.

Optimization of the VIN message handling was implemented with J500 software level 0009.

1. Follow all instructions in the attached TSB 2011732 *00 Software Version Management (SVM), operating instructions*.
2. Update the power steering gear control module (J500) using the SVM action code as listed in the table below if necessary.
