Technical Service Bulletin

94 Moisture accumulation in headlamps

94 12 91 2028277/3 October 24, 2012. Supersedes Technical Service Bulletin Group 94 number 12-68 dated March 1, 2012 for reasons listed below.

Model(s)	Year	VIN Range	Vehicle-Specific Equipment
Q7	2010-2011	000001-999999	Not Applicable
	2012	000001-004736

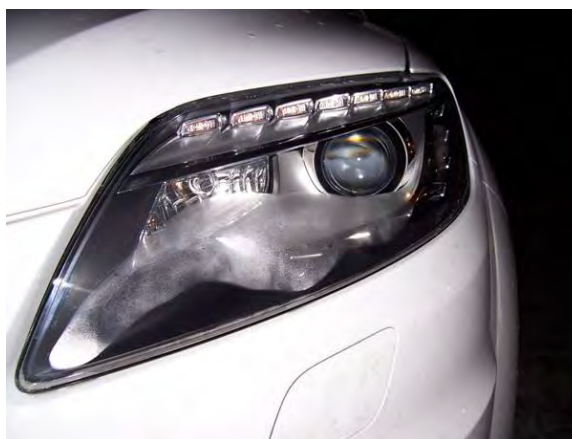
- Considerable moisture present in headlamp.
- The moisture disappears only after extended drives (greater than 10 minutes).

Figure 1. Moisture in headlamp.

Humid air settles on the inside of the glass, causing moisture to appear on the inside of the headlamp lens. Because of the headlamp circulation system, outside air is allowed to flow through the headlamps. The open, water-protected ventilation system (needed for pressure compensation) creates different “ climate zones” inside the headlamp, where the lens is either warmed up by the light or cooled down by passing air.

When high air humidity and temperature differences exist between the inside of the headlamps and the outside, condensation can form on the inside of the lens, especially in cold and wet weather. The moisture in the headlamps can be compared with condensation on the windshield, which is cleared by the "defroster vent". This moisture buildup can happen for example: after a car wash, after steam cleaning of the engine or the front end, or after overnight temperature changes.

This condition is more easily visible with headlamps made from clear glass. The moisture is an *optical condition* which **does not** affect the headlamp function (light performance) and does not lead to corrosion nor does it lead to damage of the internal headlamp parts.

1. Remove the headlamps and dry the inside using compressed air or hot air blower.

2. Replace the headlamp ventilation hose for each headlamp with the new part number to help reduce any further humidity ingress into the headlamps (see Part information table below).

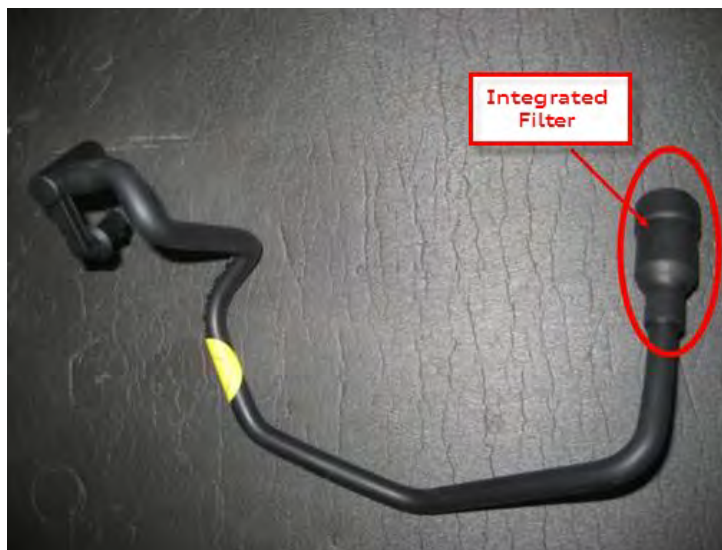
The modified ventilation hose can be recognized by the integrated filter as seen in Figure 2.

Figure 2. Ventilation Hose with Integrated Filter
