Technical Service Bulletin

94 Side mirror turn signal inoperative

94 12 90 2030956/2 October 8, 2012. Supersedes Technical Service Bulletin Group 94 number 12 – 88 dated September 25, 2012 for reasons listed below.

Model(s)	Year	VIN Range	Vehicle-Specific Equipment
A4	2009 – 2013	All	Not Applicable
A5	2008 – 2013		
Cabriolet	2010 – 2013		
A3	2009 – 2013

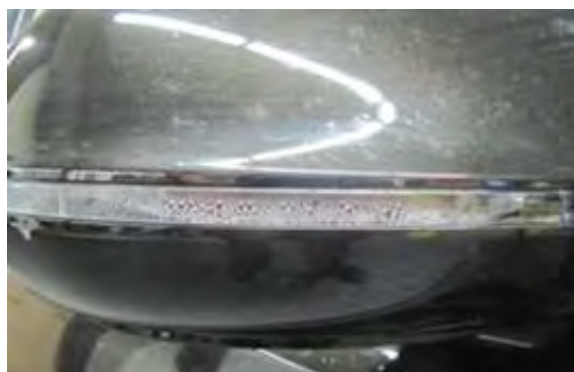
The turn signal indicator lens is inoperative without any damage from outside influence. Cracks have formed in the lens and as a result condensation can be seen behind the lens as shown in Figure 1.

Figure 1 Condensation in turn signal lens

The turn signal lens can crack due to the high amount of tension in the side mirror housing. The tension is due to improper installation of the mirror at the factory and is not a defect in the mirror housing. Replacing the mirror housing will not affect this condition.

1. Remove the side mirror as instructed by the ElsaWeb Repair manual.

2. Replace the damaged turn signal lens in the side mirror.

3. Test turn signals.
4. Clear DTCs in electrical system.
