# Technical Service Bulletin

## 94 Rear side marker light inoperative in lower rear bumper

94 12 95 2029782/2 October 25, 2012. Supersedes Technical Service Bulletin Group 94 number 12-78 dated June 4, 2012 for reasons listed below.

Model(s)	Year	VIN Range	Vehicle-Specific Equipment
Q5	2010-2013	All	Not Applicable

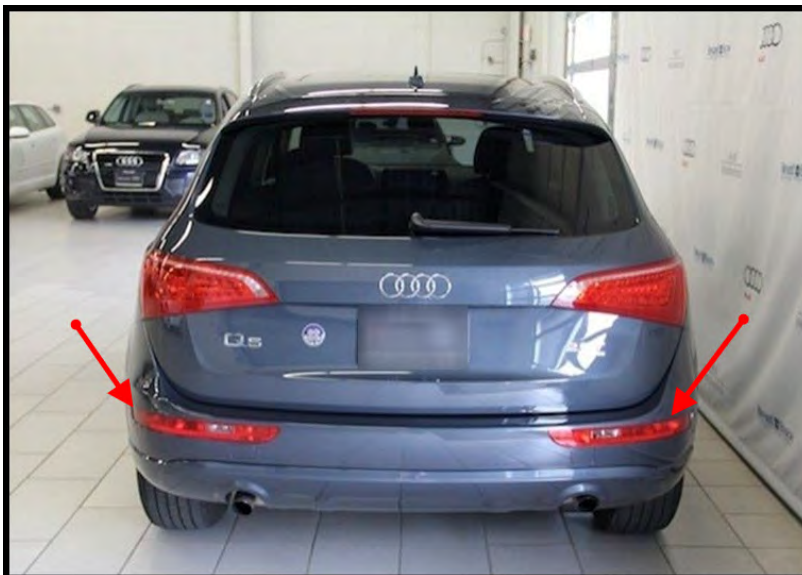
A “ bulb out” warning is active in the instrument cluster’ s Driver Information System (DIS) display and one or both of the rear side marker lights are burnt out.

Figure 1. Rear side marker lights.

Moisture and debris can enter into the lower taillight housing causing one or more of the bulbs to burn out.

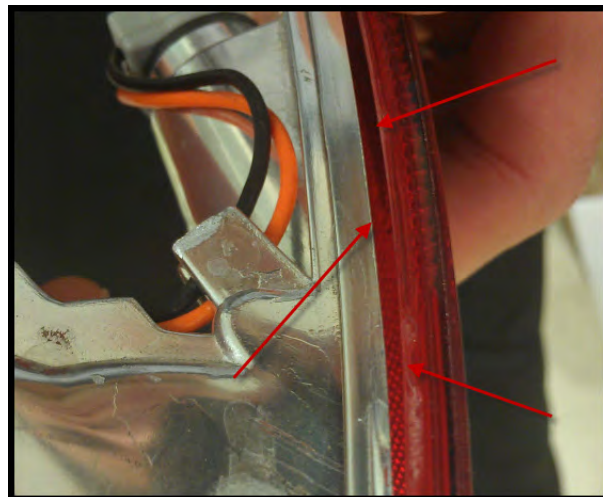
Inspect the lens for any separation around the red, reflecting edge of the taillight lens (Figure 2). Separation will take the form of a red color shade change along the seam. It may look more opaque than the rest of the perimeter.

*Figure 2. Taillight Lens separation.*

2. If there is any separation at all, then please replace the complete taillight housing. Keep the good bulbs and any wiring, and only replace the housing and any burnt out bulbs. Wipe all original, intact bulbs with alcohol prior to install, keeping any foreign matter, grease, oil from hands, etc. off of the bulbs.
