Service Bulletin

Bulletin No.: PIP5066

Subject: Engine Overheat or Cooling Fans Inoperative

Models: 2013 Cadillac ATS

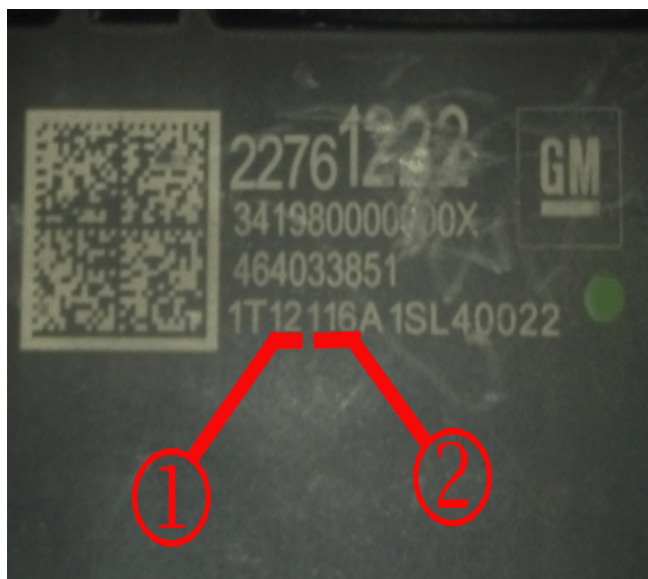
2915185

This may be the result of a concern with the Cooling Fan Control Module.

First verify if the Cooling Fan Control Module has a suspect date code (Refer to picture below).

Any date code less than 12207 (23JUL12) is suspect.

If the Cooling Fan Control Module is suspect then use the service scan tool and procedure below to perform a system check on the Cooling Fan Control Module.

Command the Engine cooling fan through states 1-5 with the engine running at idle for approximately 20-30 minutes in order to get the under-hood temperature hot (The front grille may be blocked to reduce test time).

If the electric cooling fan stops working then replace the Cooling Fan Control Module:
