# Service Bulletin

Bulletin No.: PIC5757

**Subject:** Blower Motor Inoperative and/or Water In Blower Motor Control Module Area DTC B0193

**Models:** 2013 Chevrolet Malibu eAssist

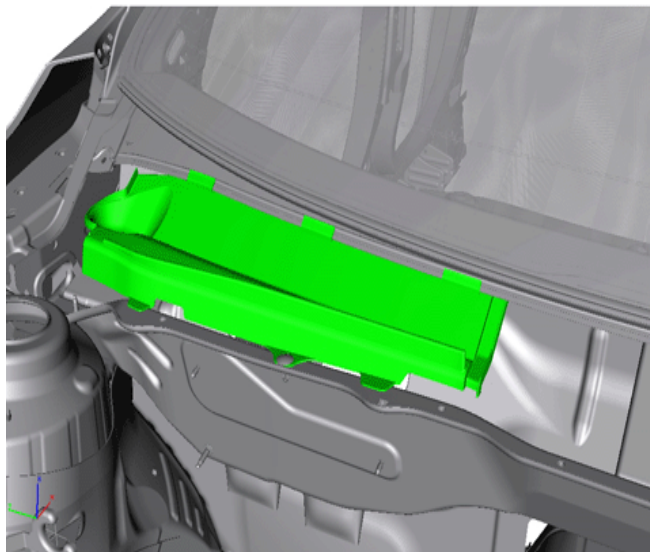
2919801

A customer or technician may indicate the blower motor is inoperative and/or there is water in the blower control module motor area. DTC B0193 may also be set.

If this concern is duplicated inspect the blower motor, blower motor control module and connectors for signs of water. If water is found it will be necessary to reseal the plenum deflector (see images below) and then replace parts and repair connectors as needed. Remove the air inlet grille to access the plenum water deflector.
